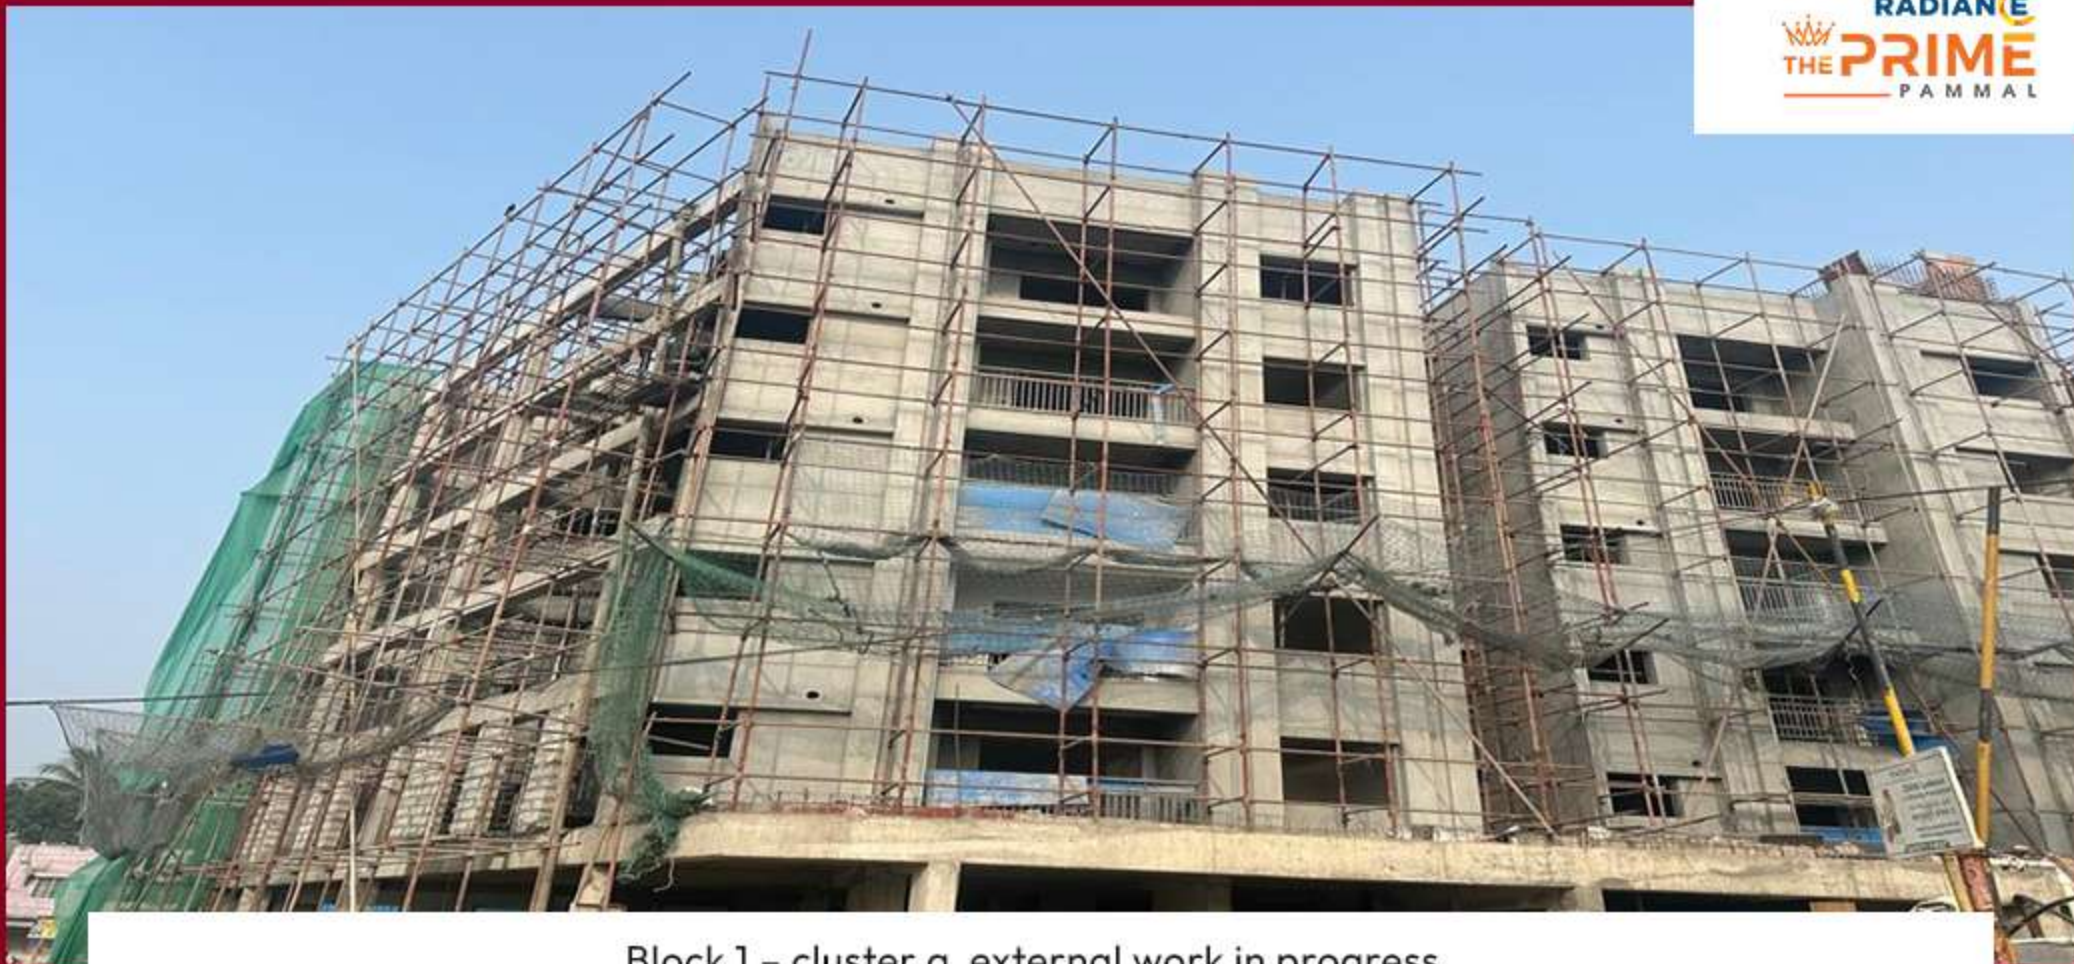
Block 1 – cluster a external work in progress.

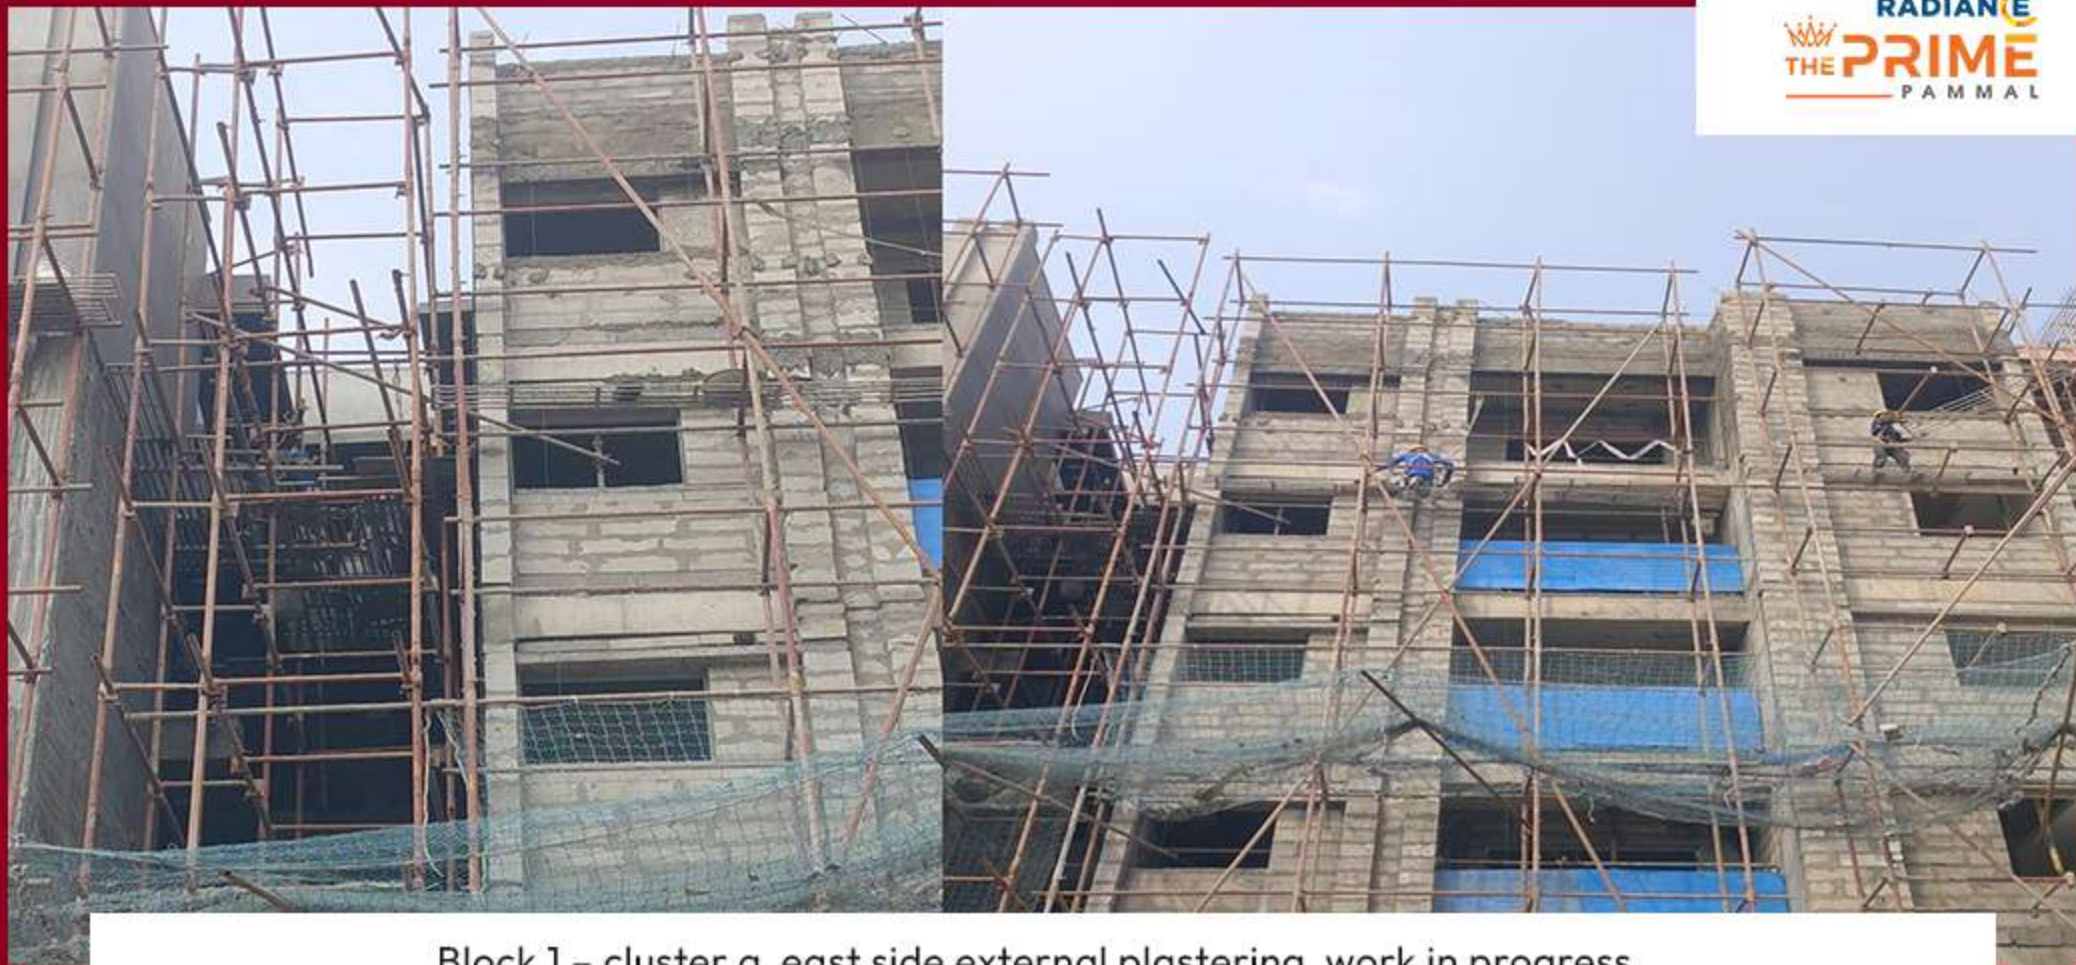
Block 1 – cluster a east side external plastering work in progress.

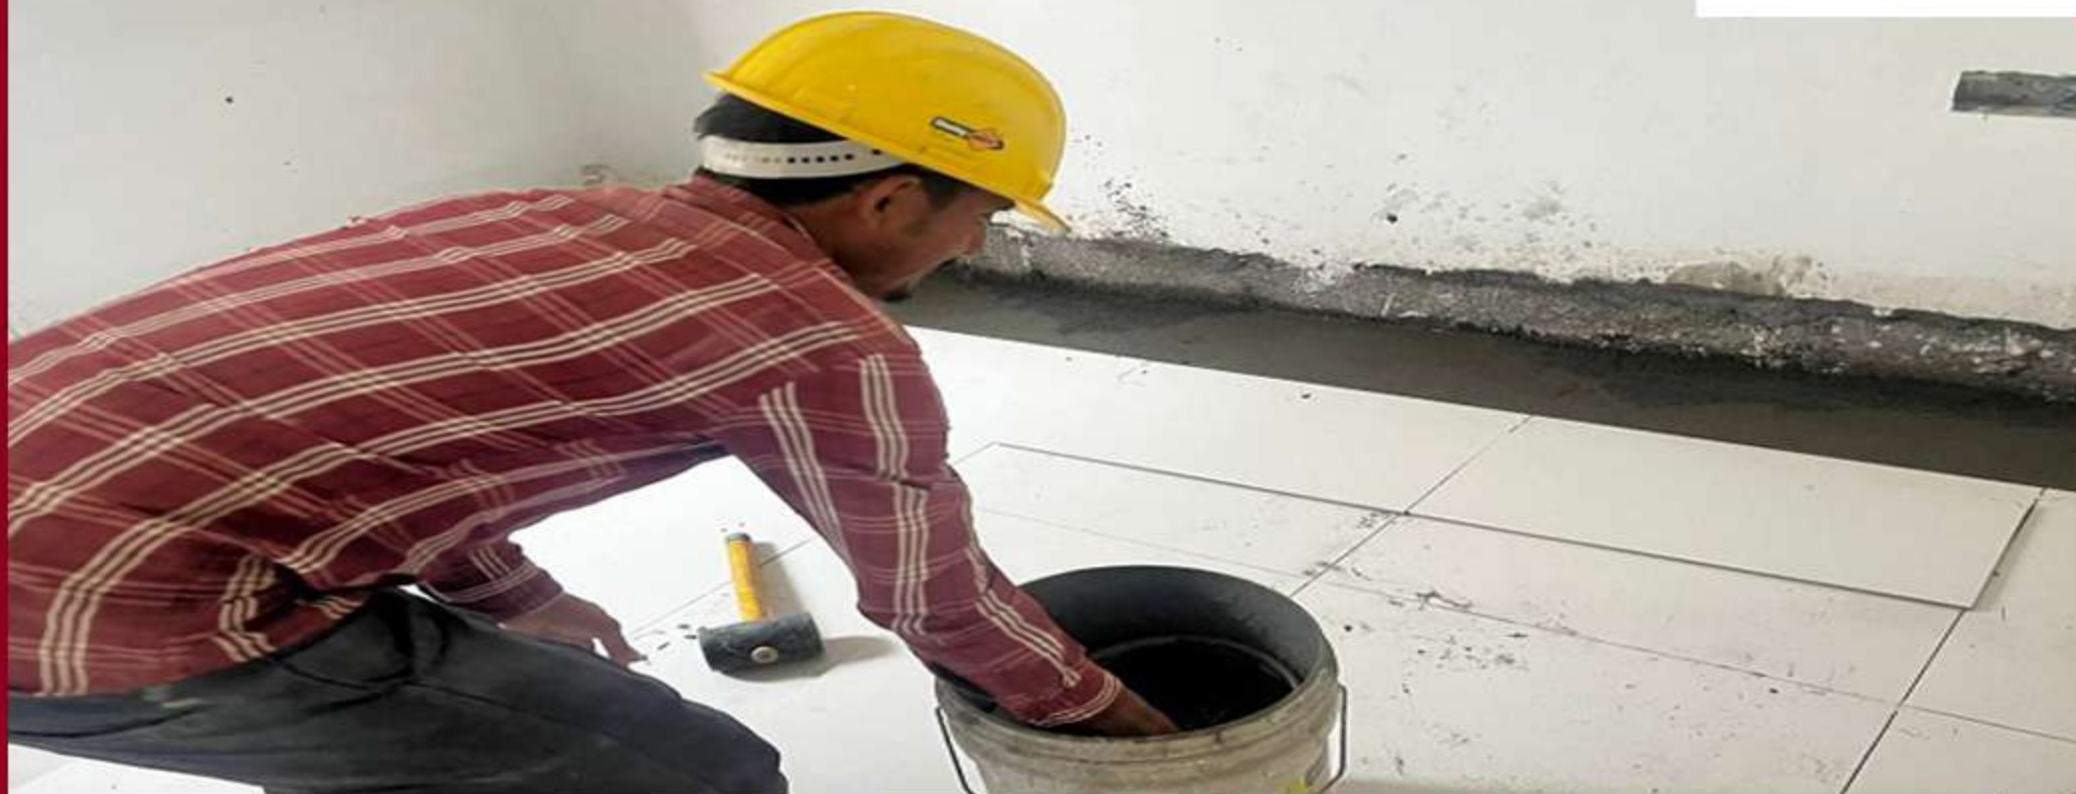
Block 1 – cluster b 1st floor tile work in progress.

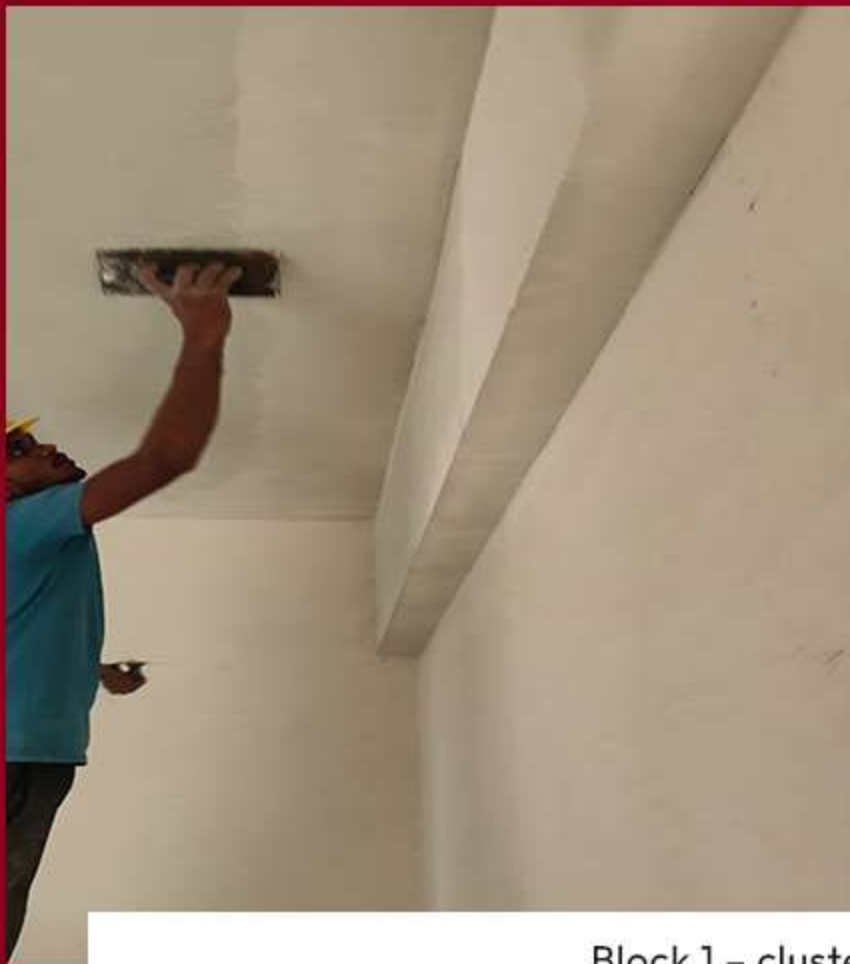
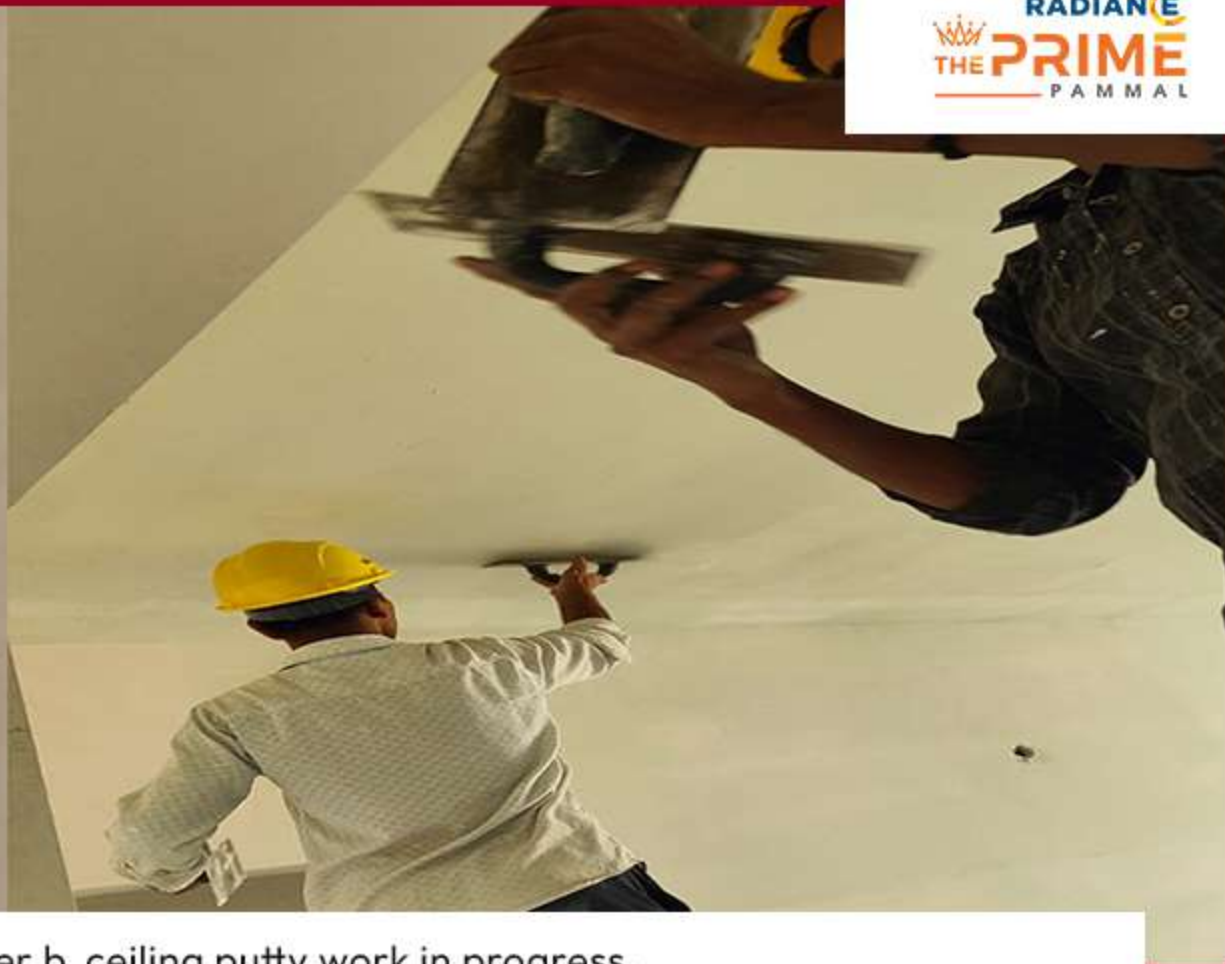
Block 1 – cluster b ceiling putty work in progress.

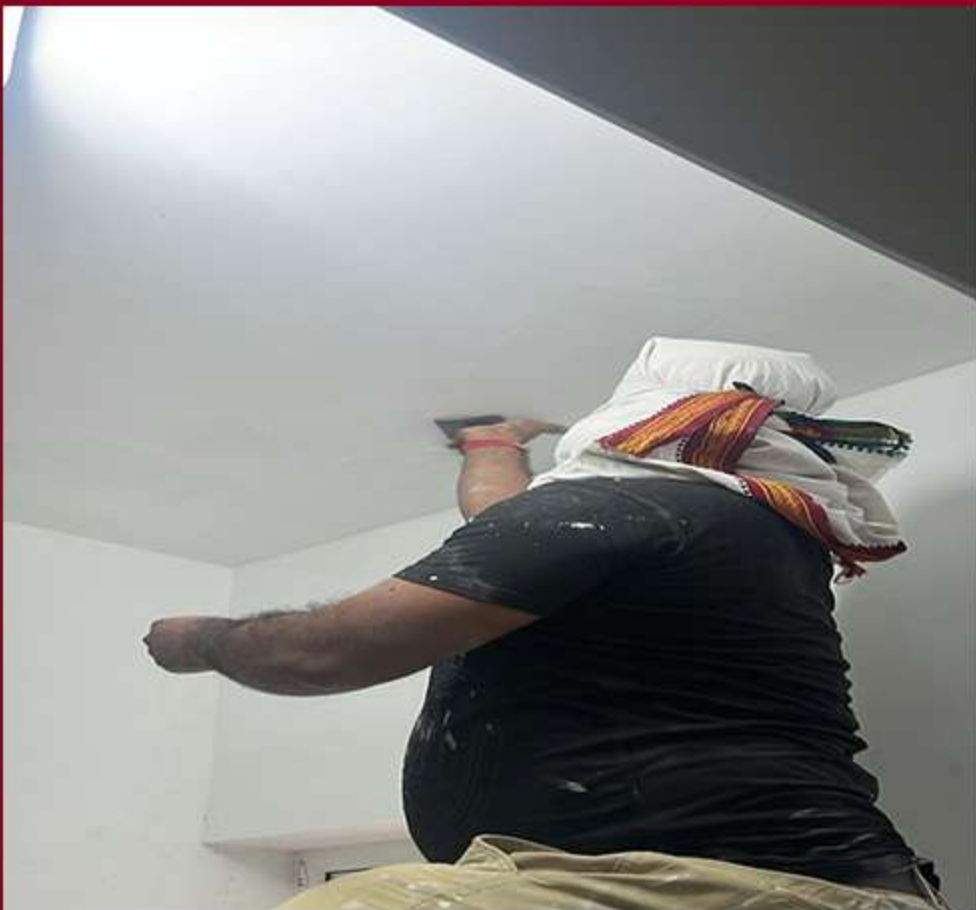
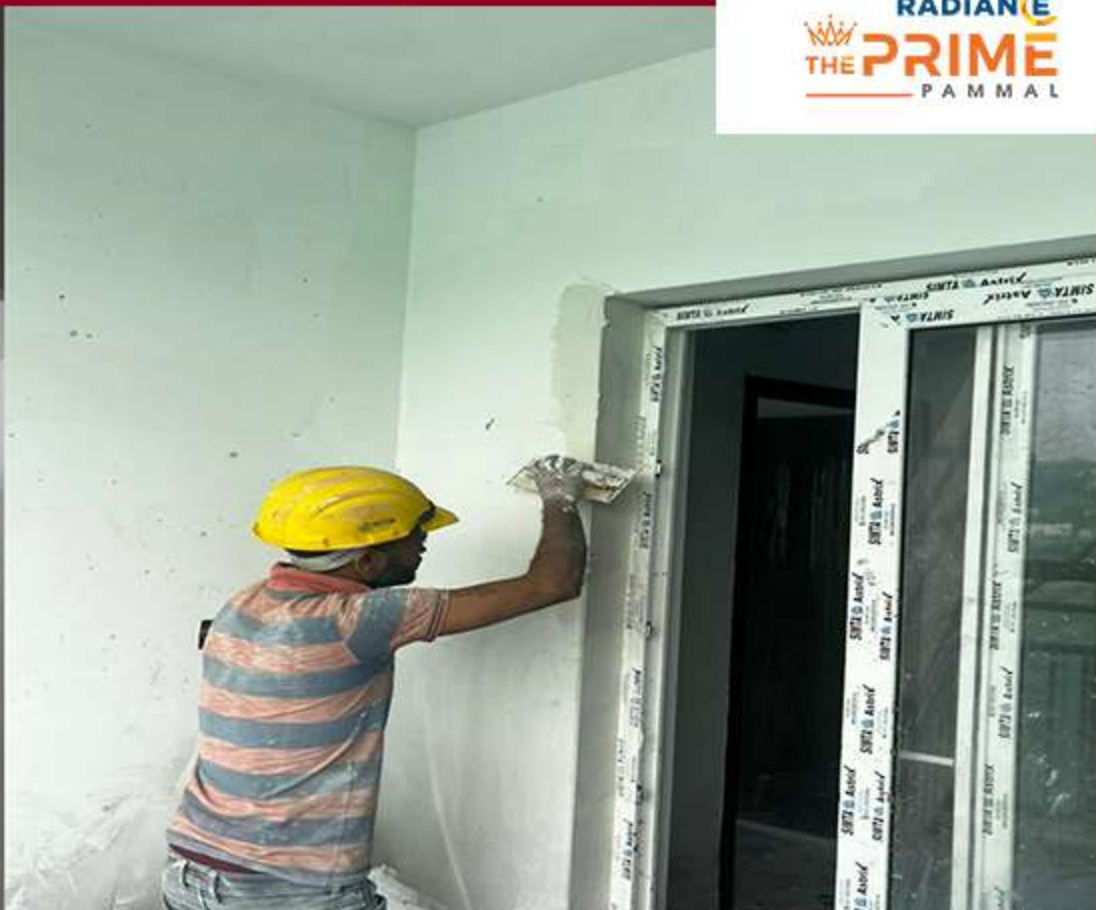
Block 1 – cluster a putty work in progress.

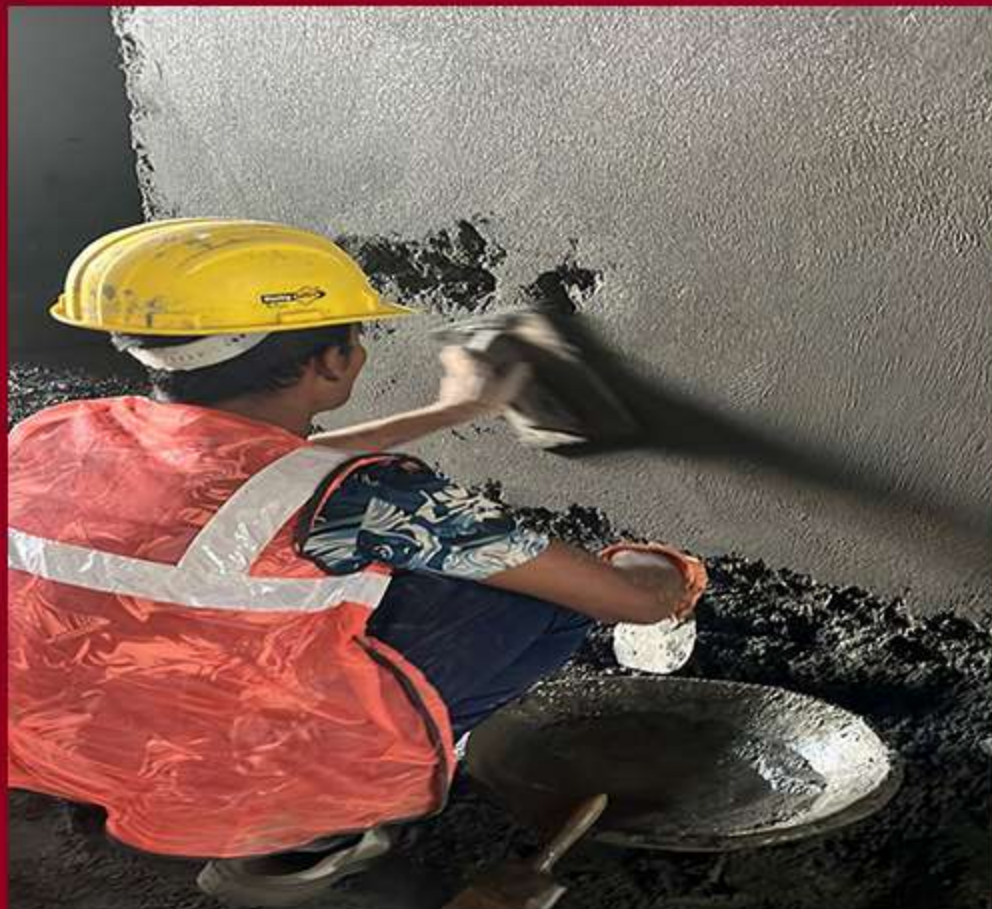
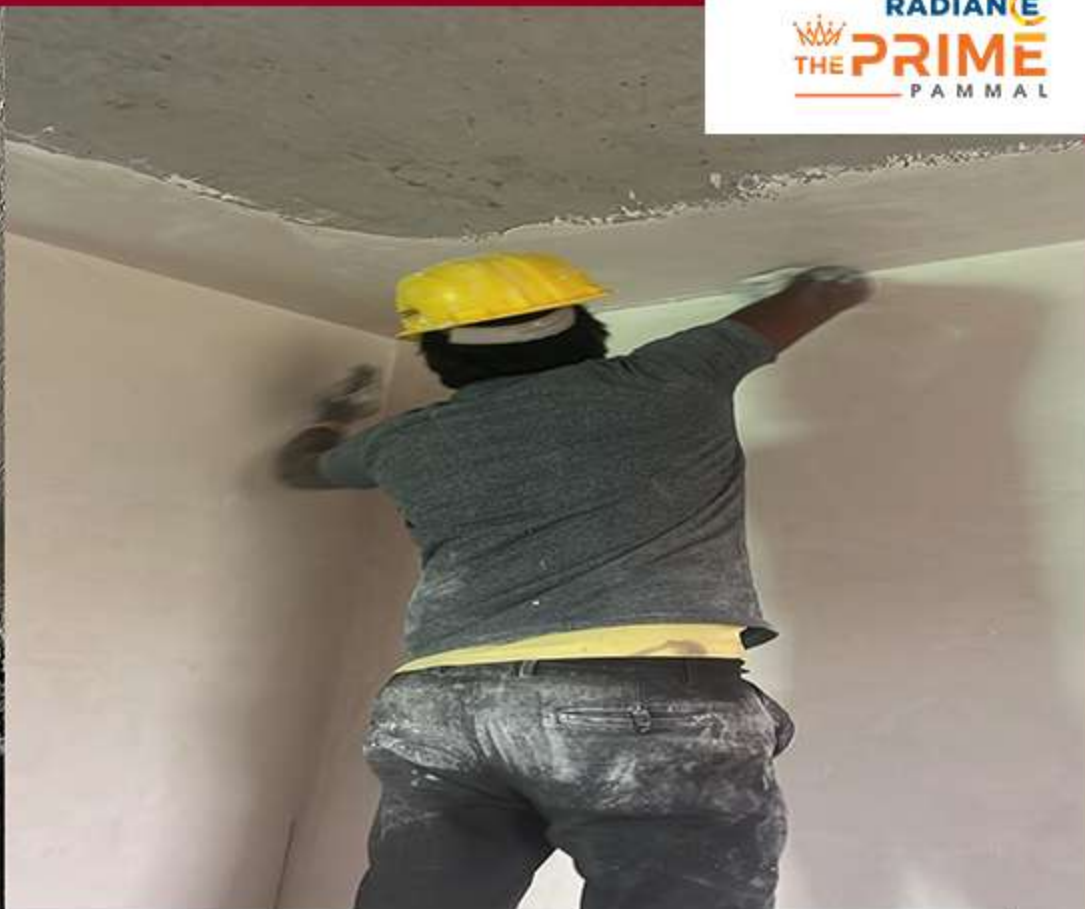
Block 1 – cluster a internal plasteringwork in progress.

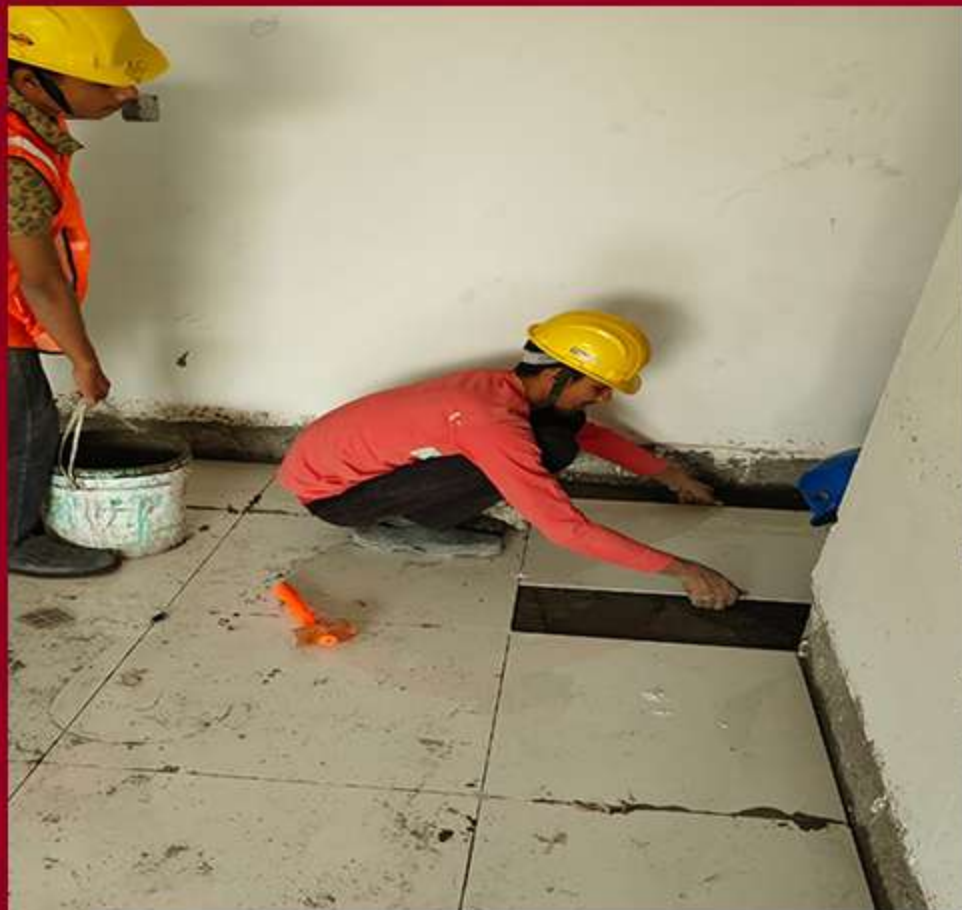
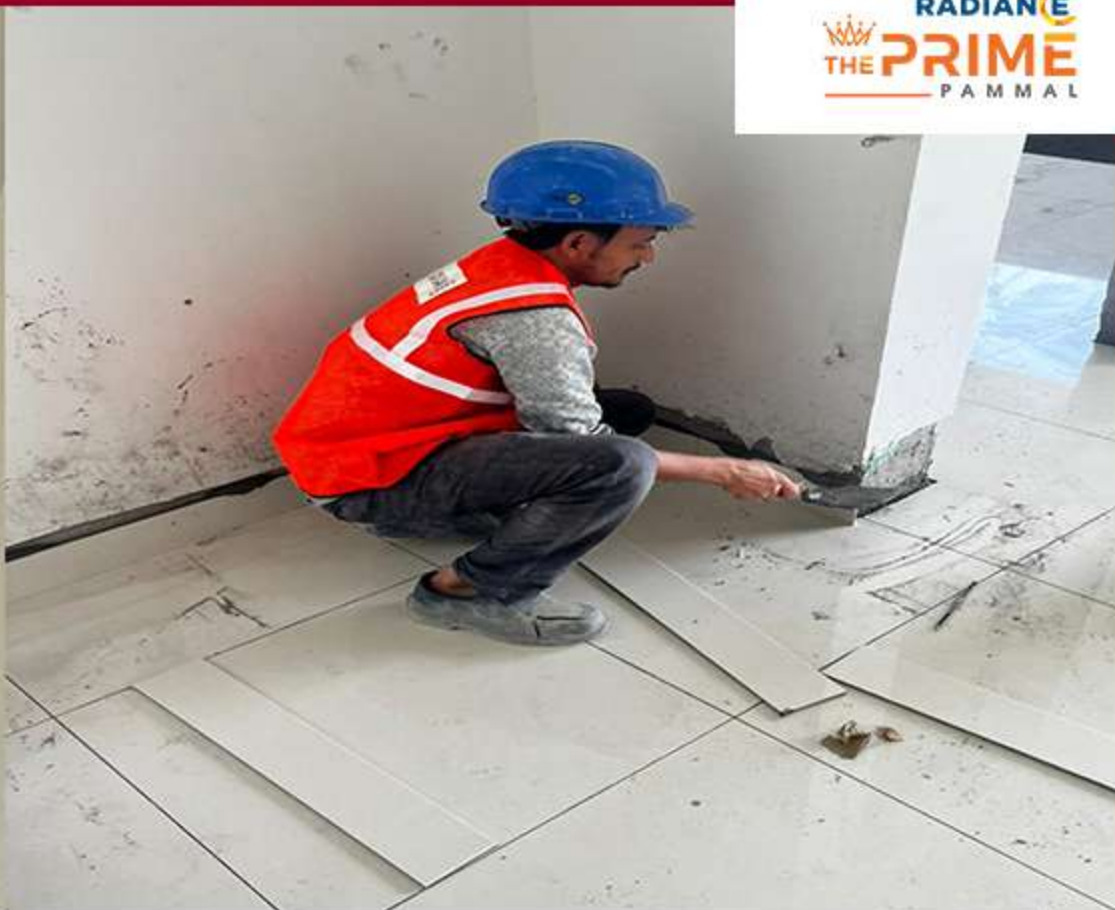
Block 1 – cluster B tile work in progress.

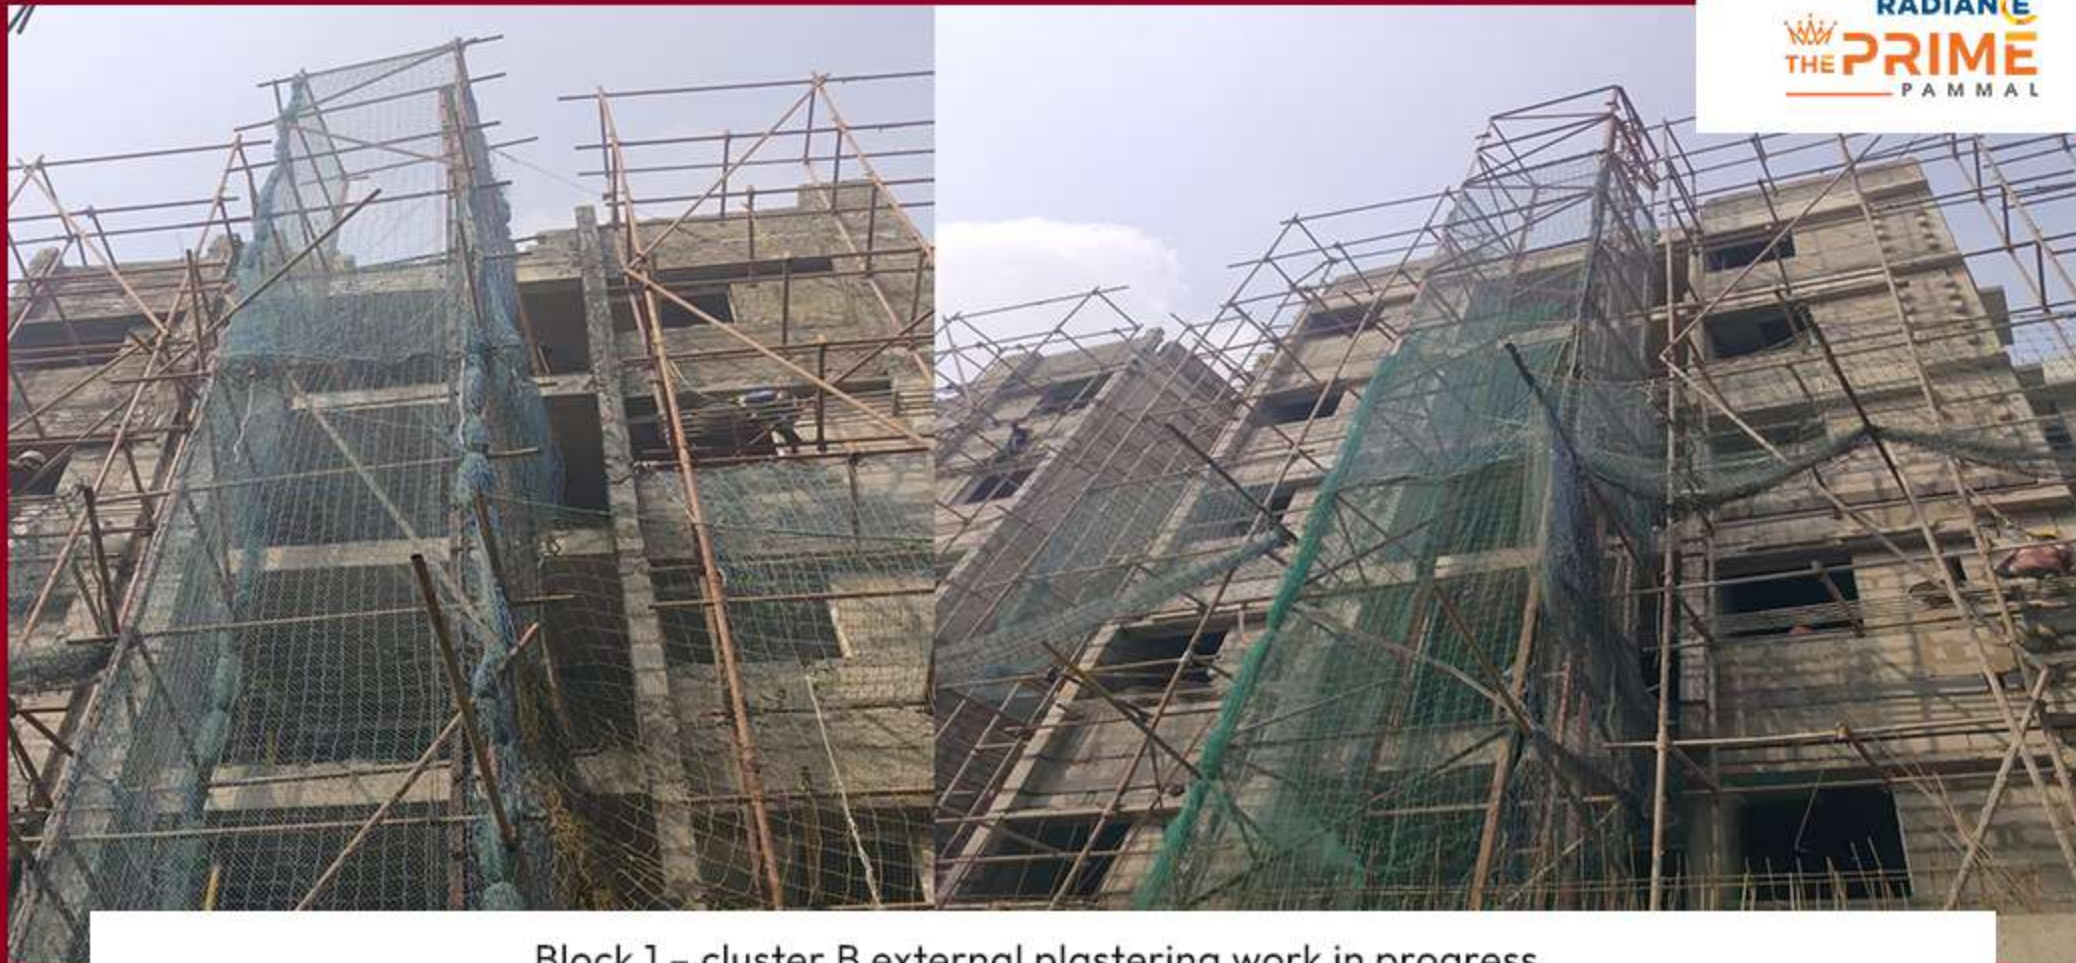
Block 1 – cluster B external plastering work in progress.

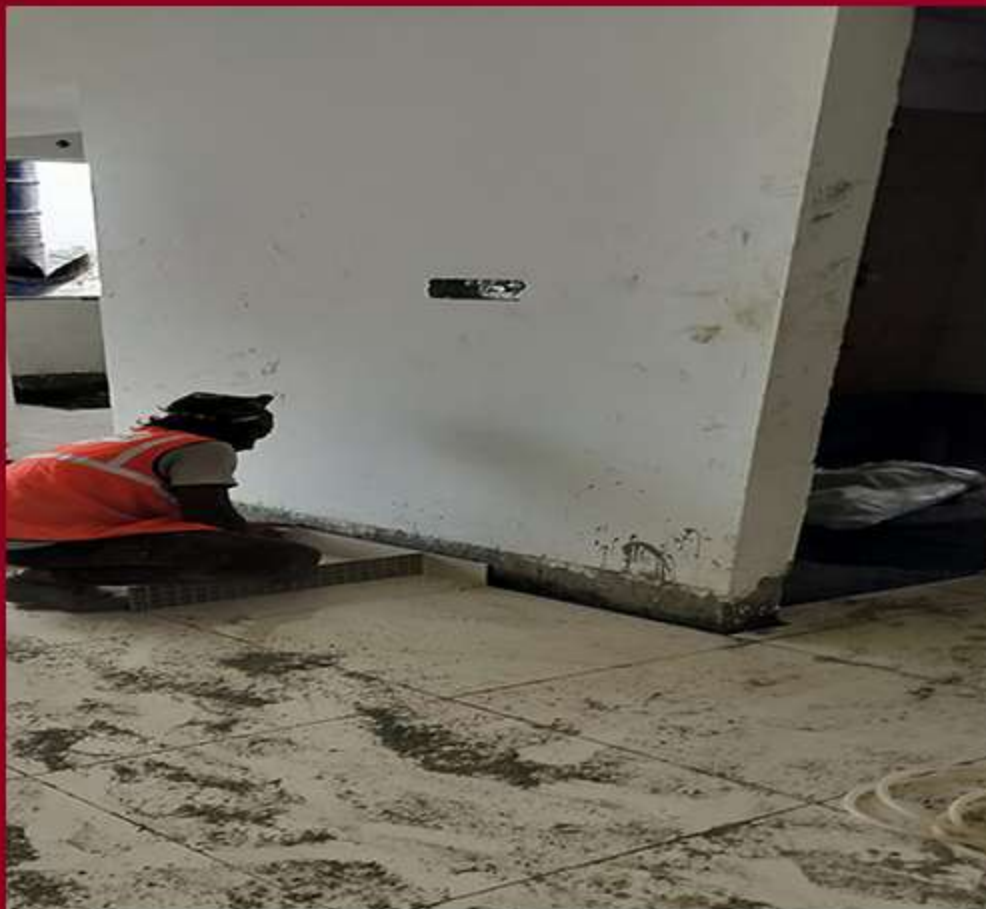
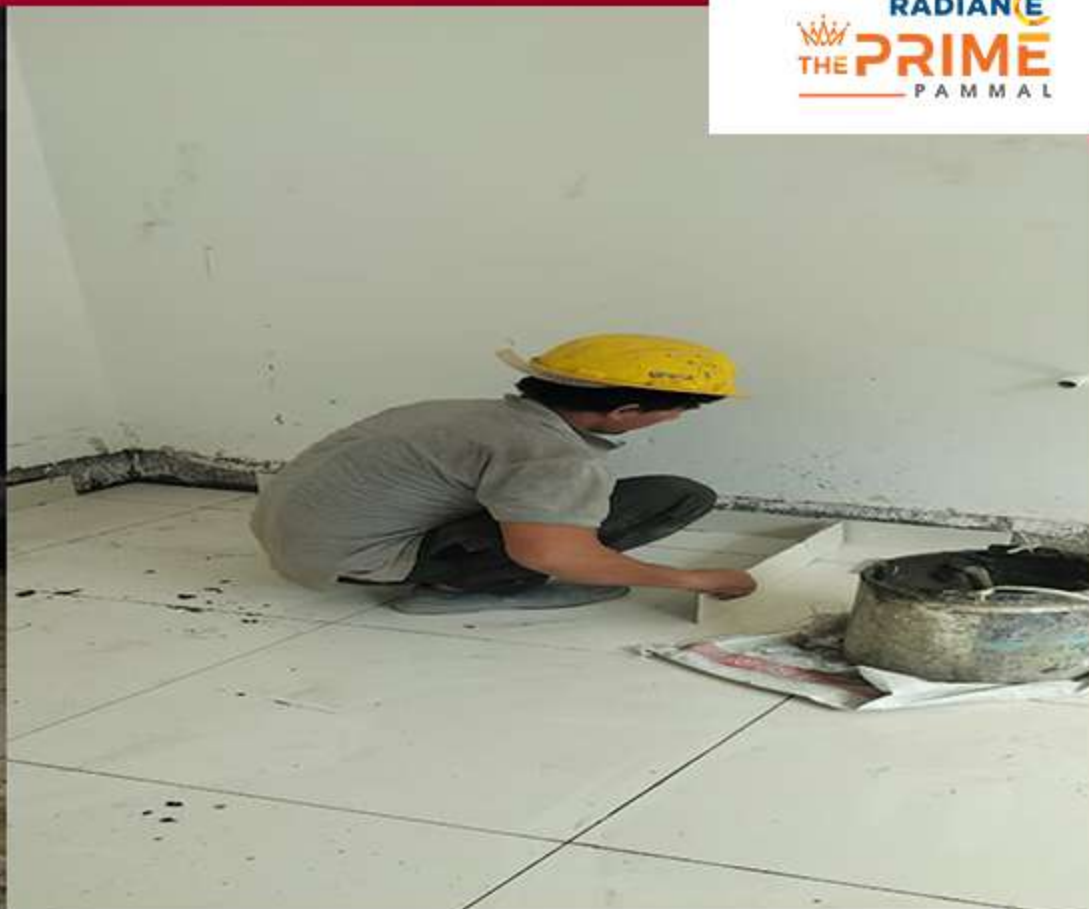
Block 1 – Cluster C Tile Work in Progress.

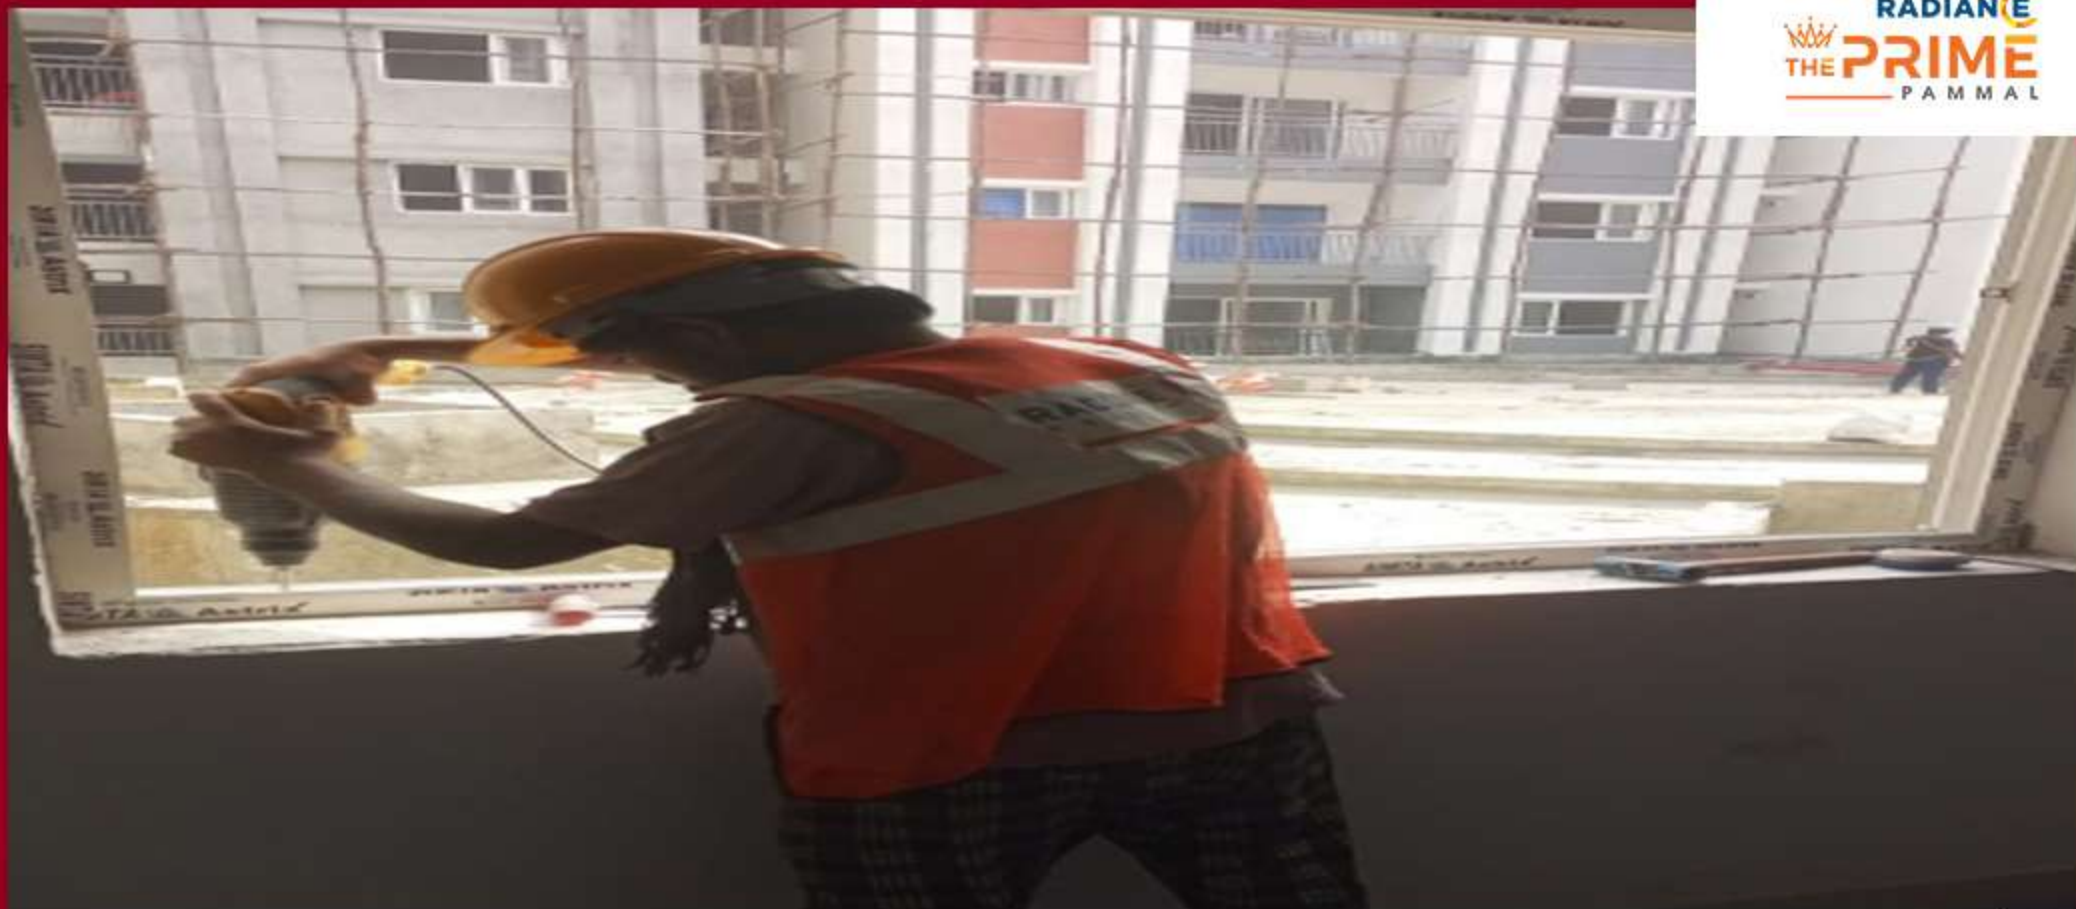
Block 1 – Cluster C upvc window fixing work in progress.

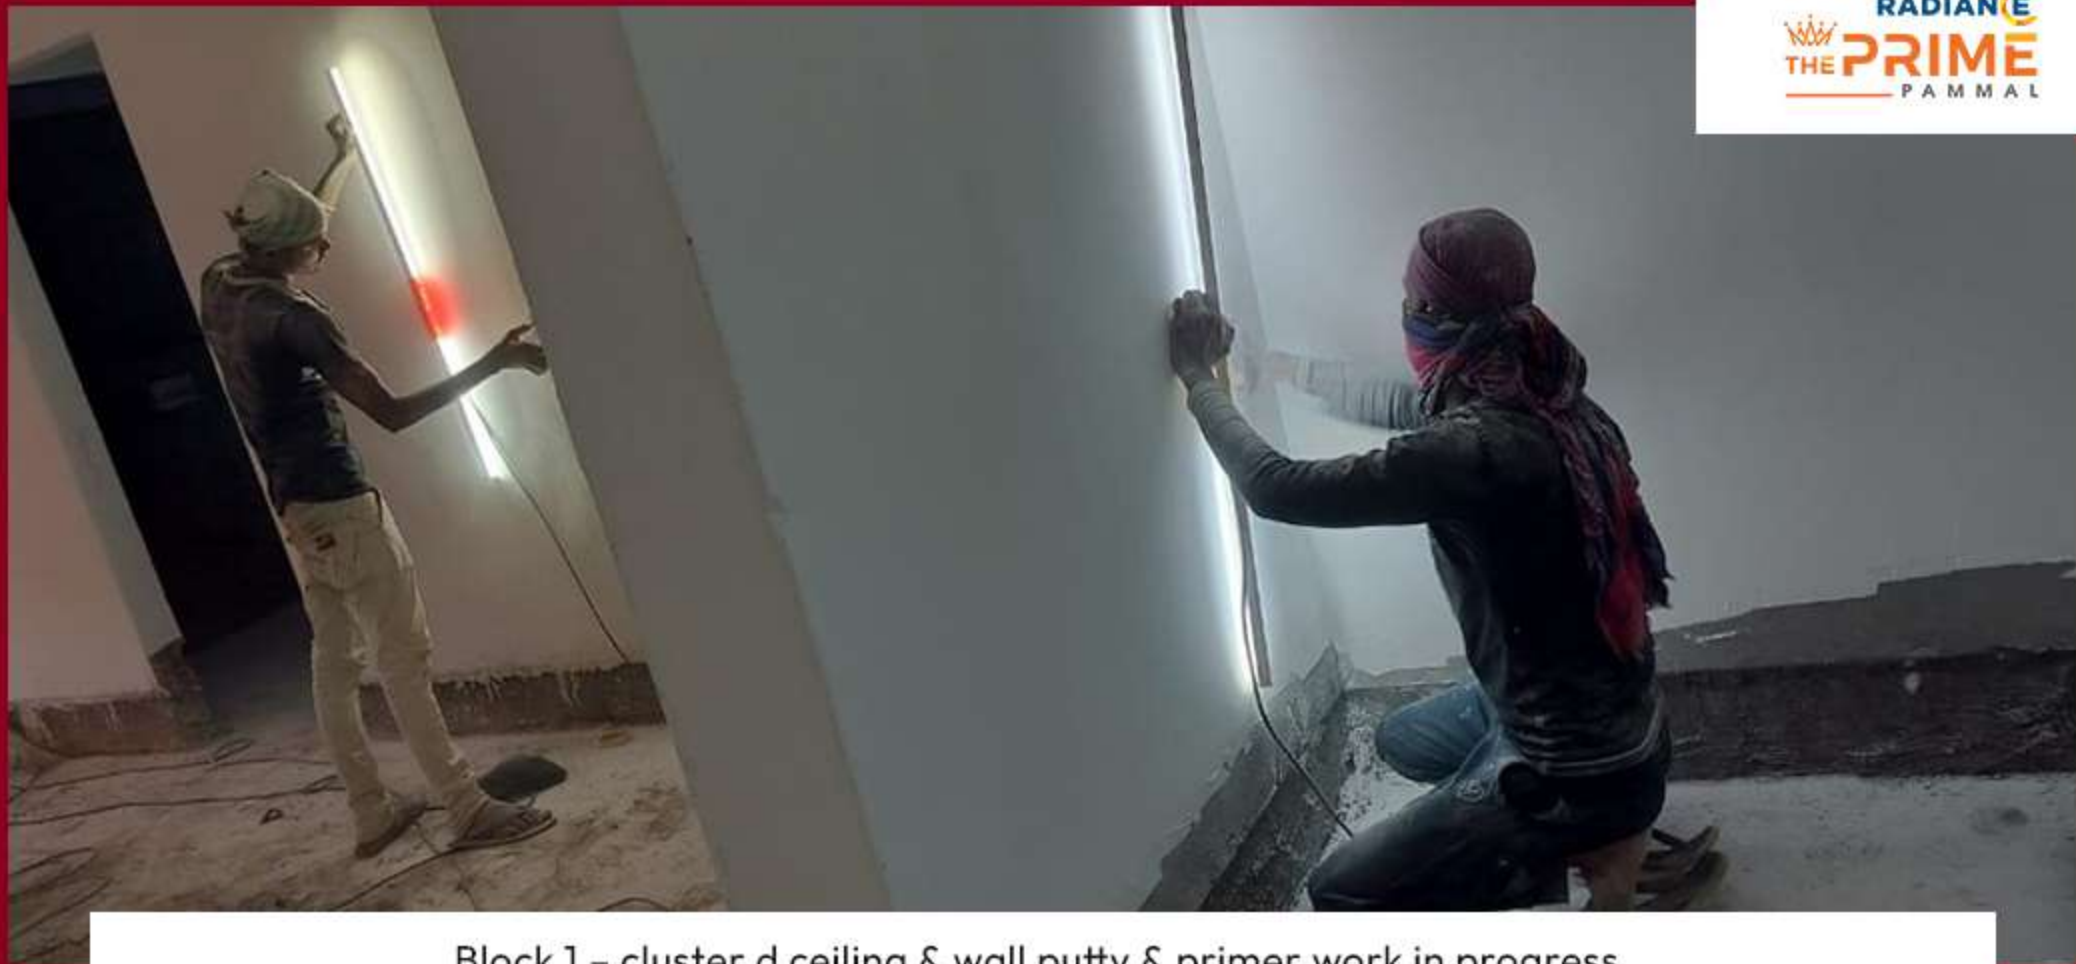
Block 1 – cluster d ceiling & wall putty & primer work in progress.

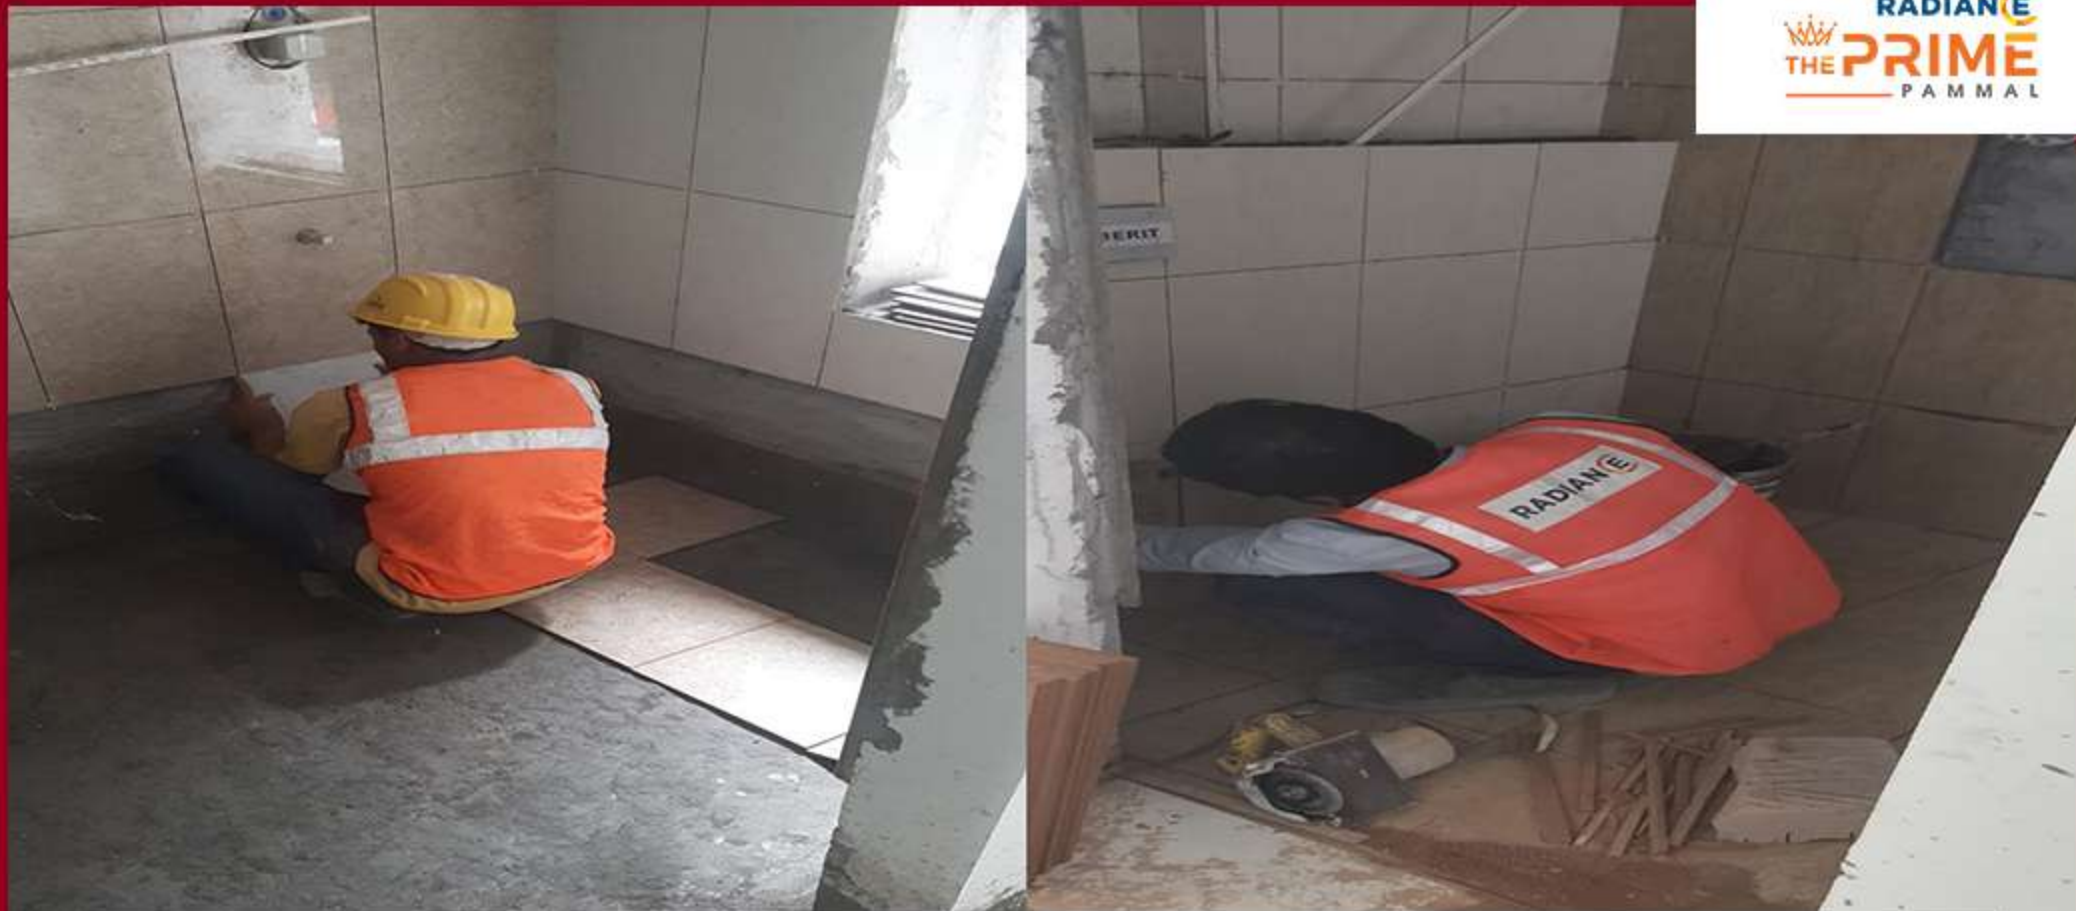
Block 1 – Cluster D Tile Laying Work In Progress.
