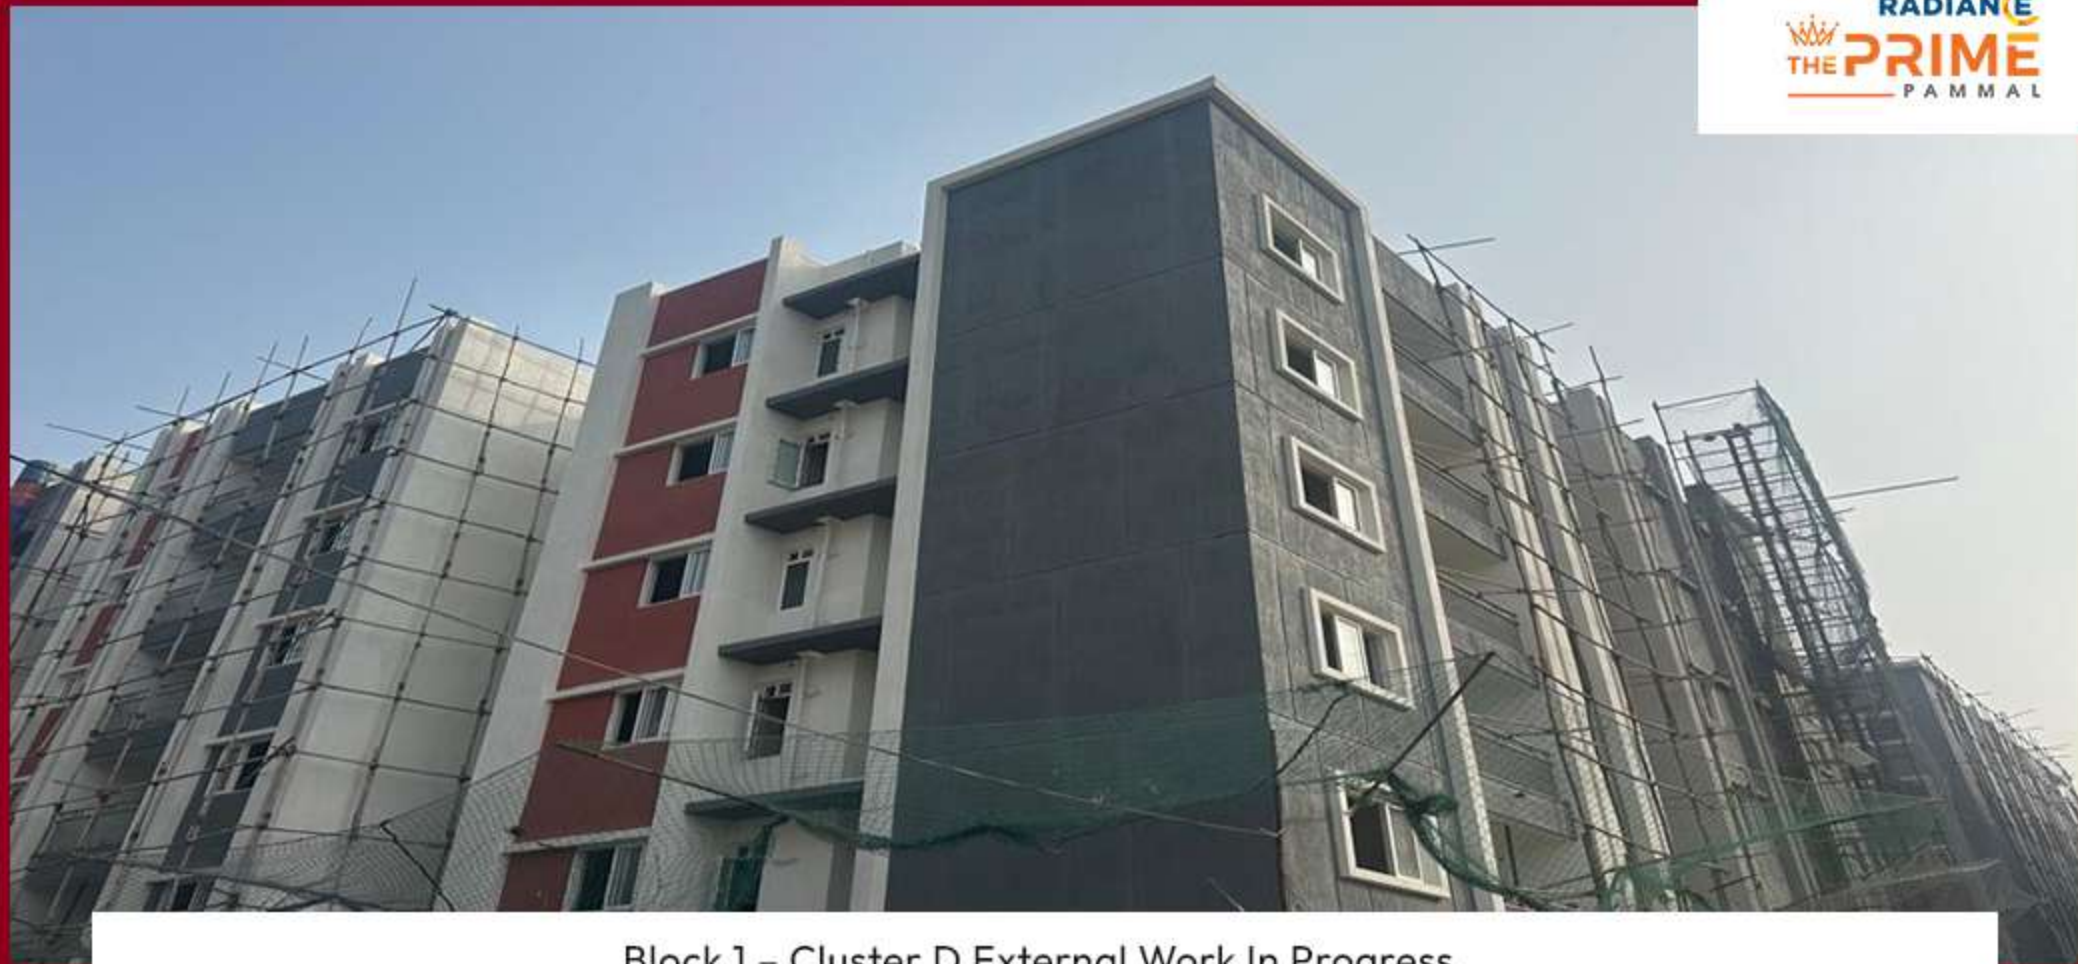
Block 1 – Cluster D External Work In Progress.

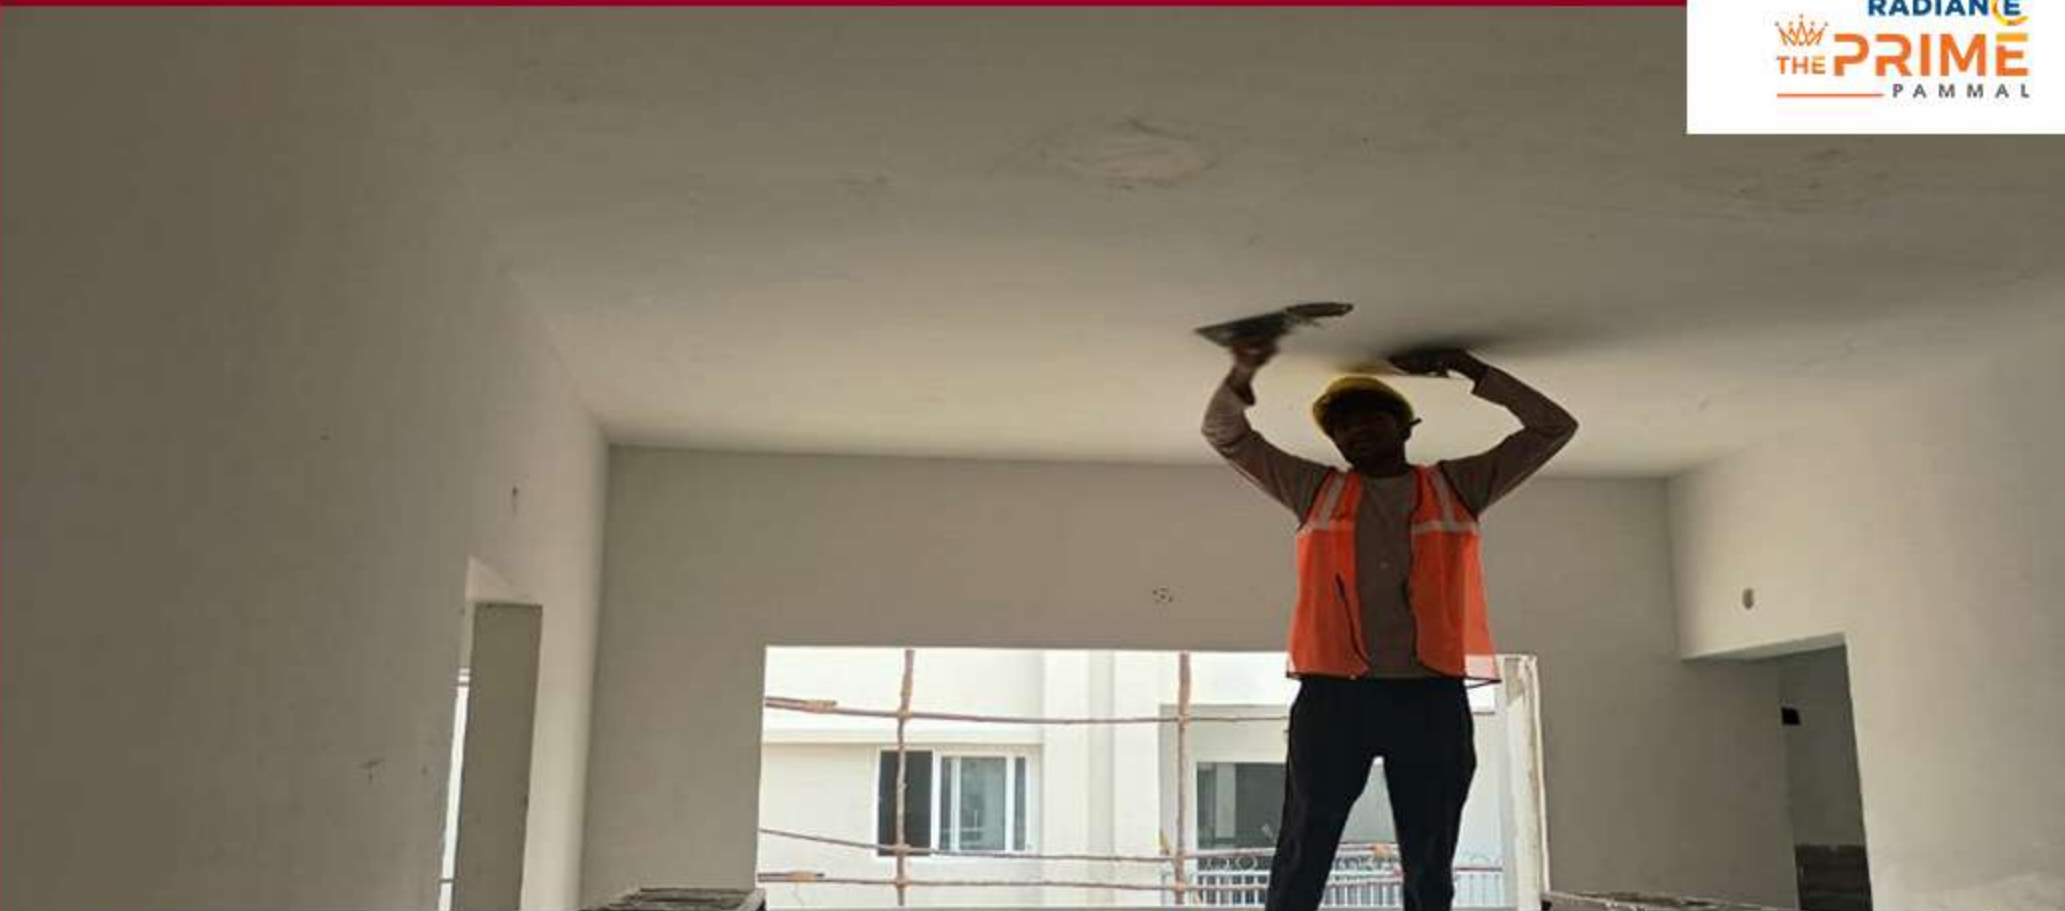
Cluster e ceiling & wall putty work in progress.

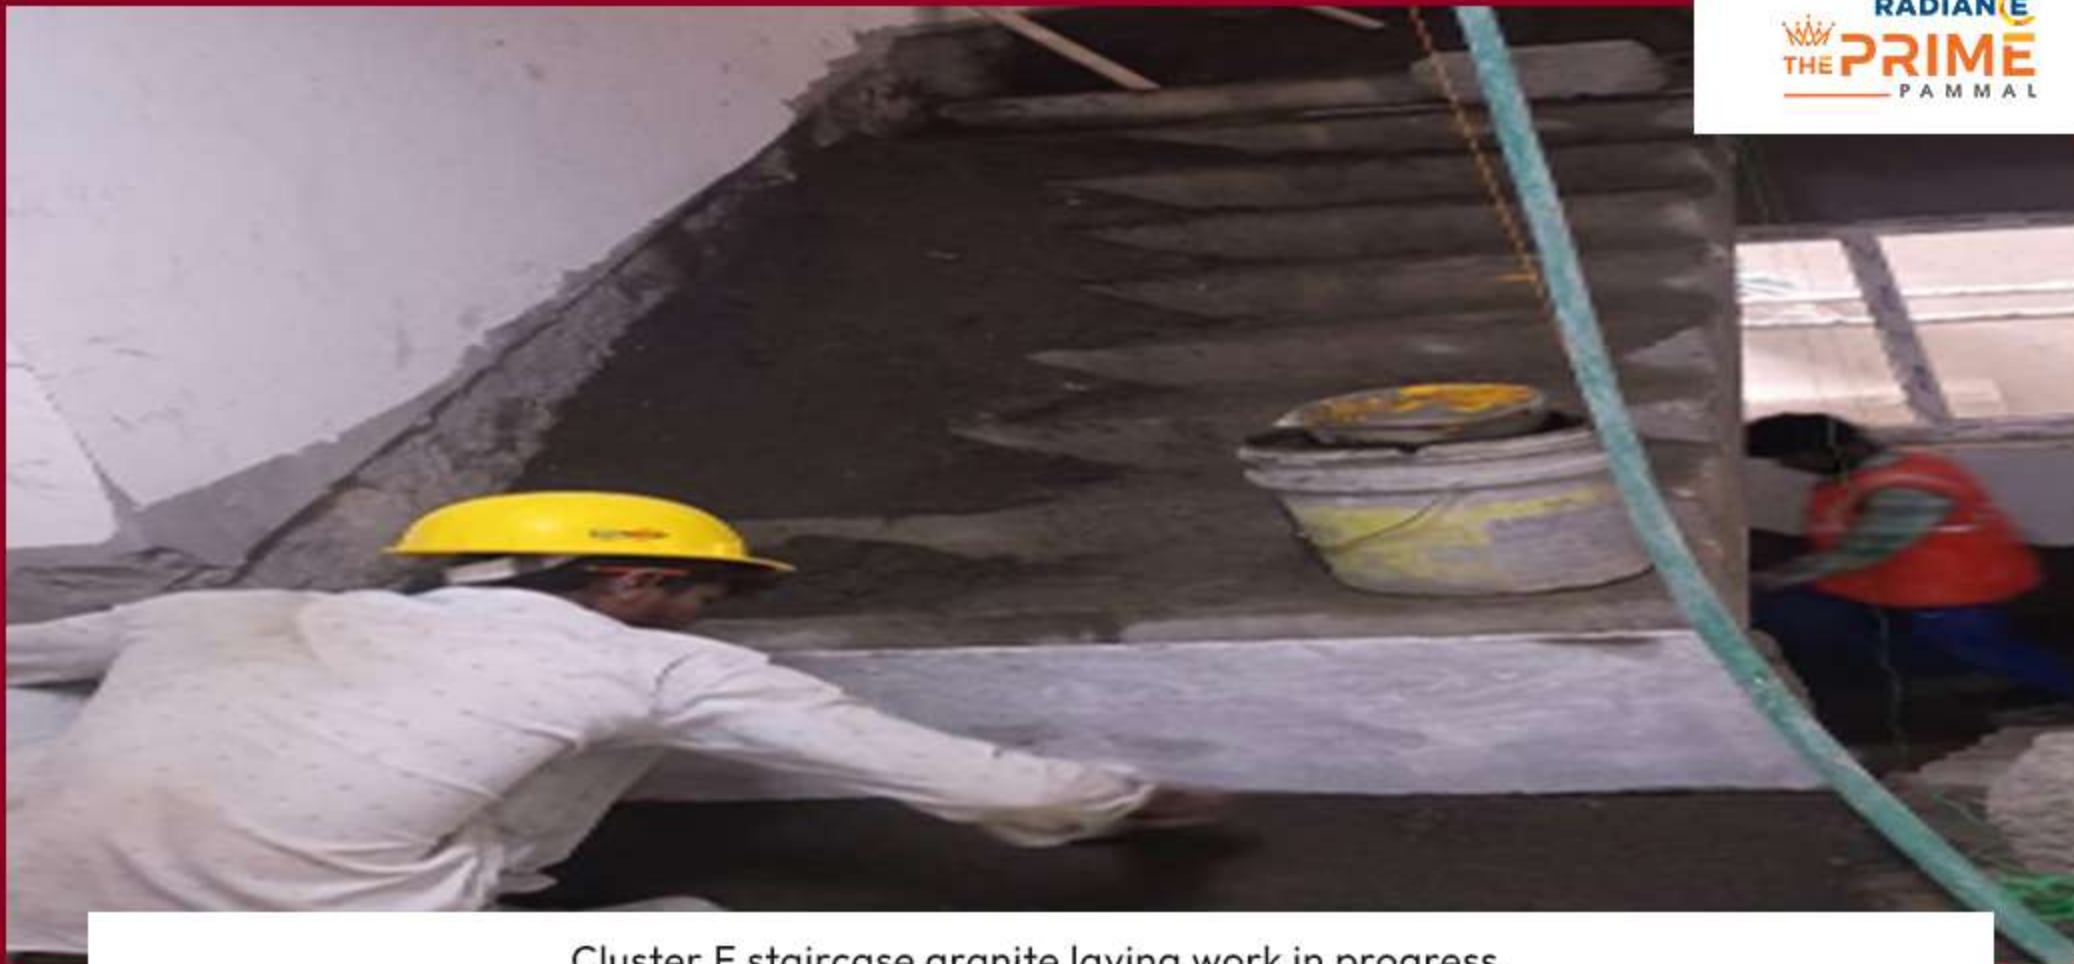
Cluster E staircase granite laying work in progress.

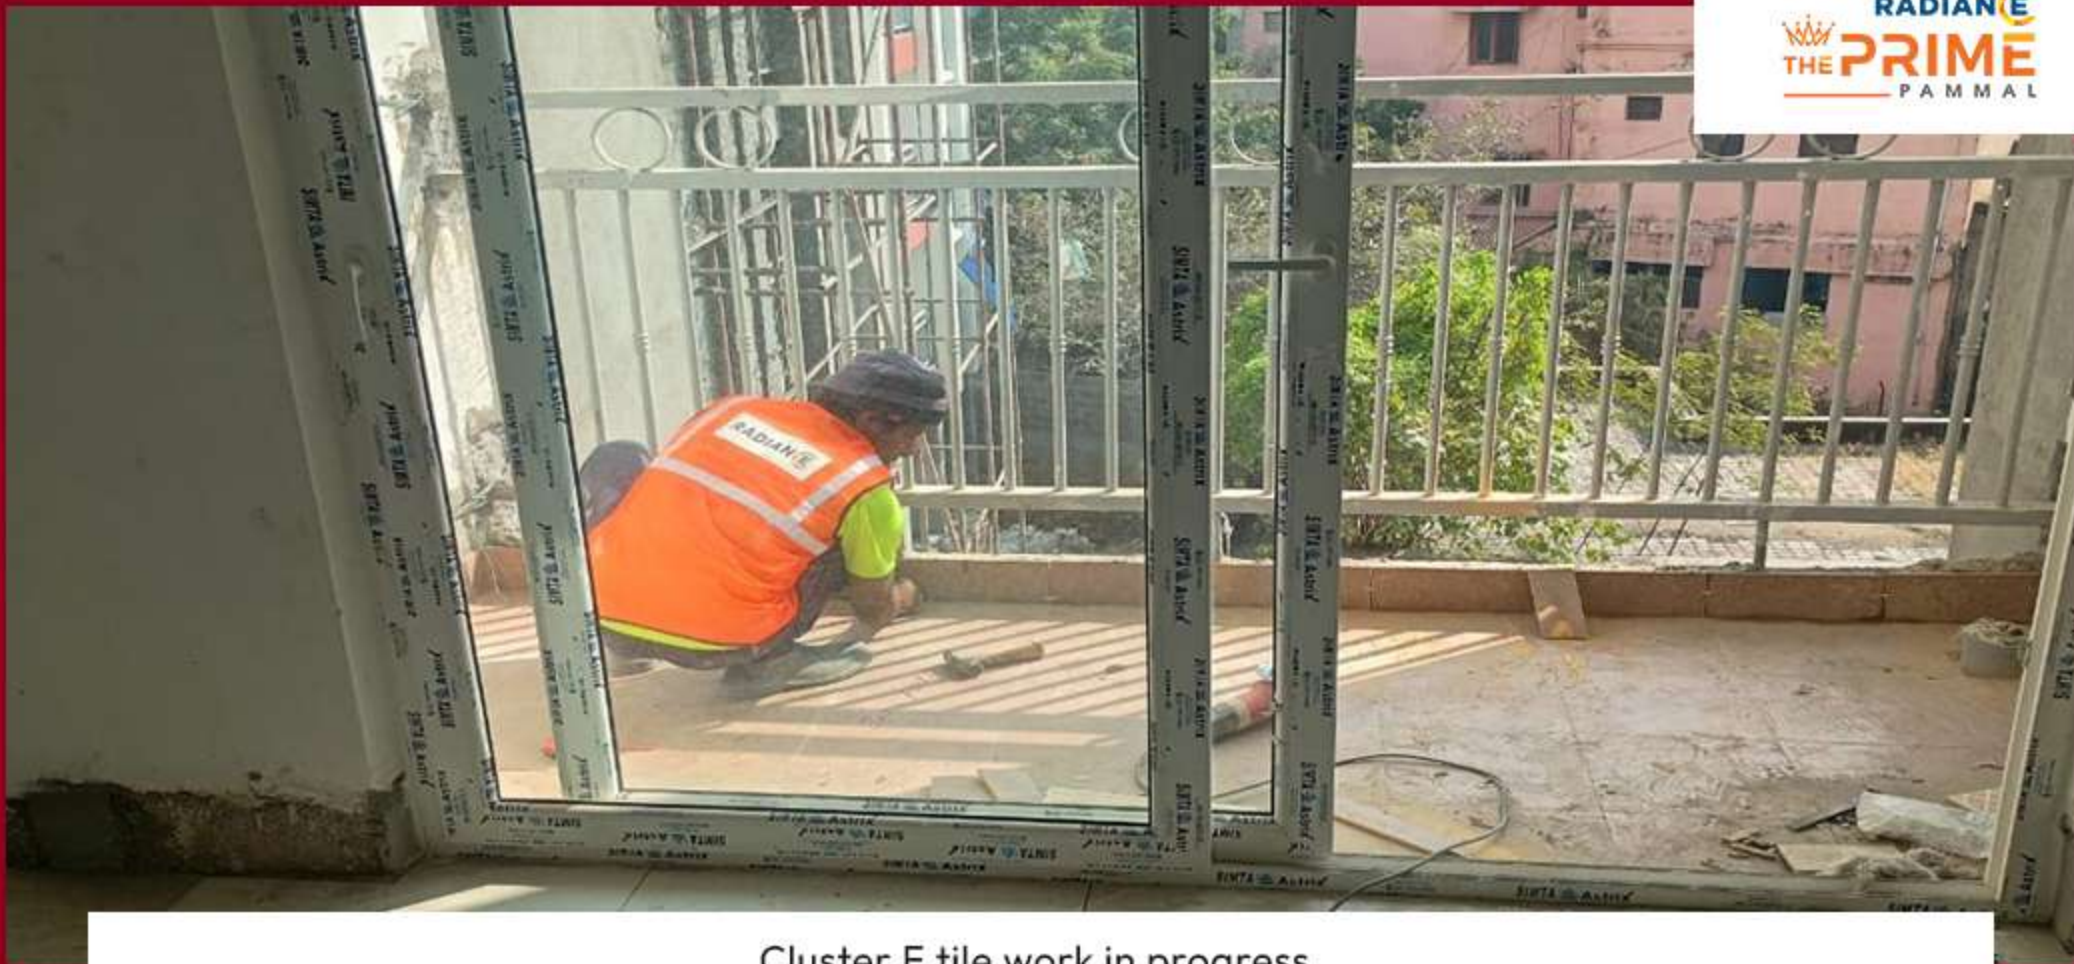
Cluster E tile work in progress.

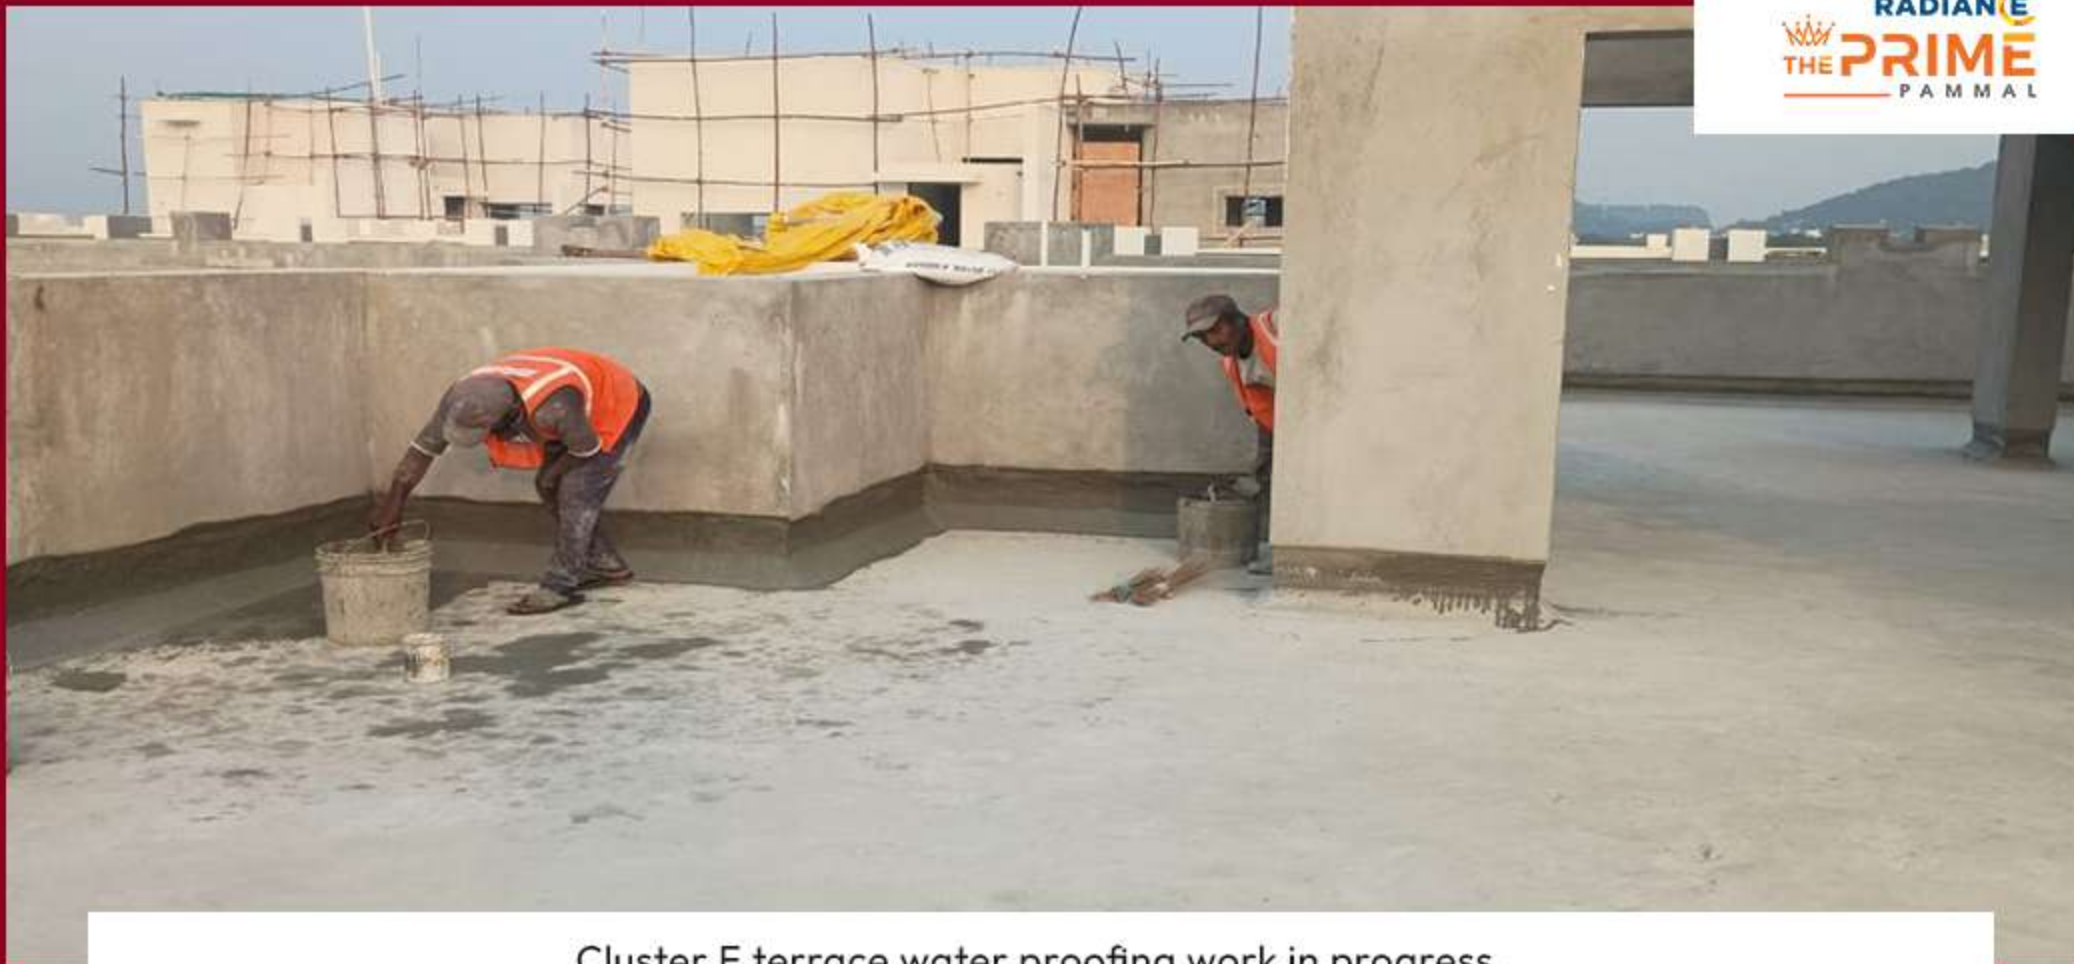
Cluster E terrace water proofing work in progress.

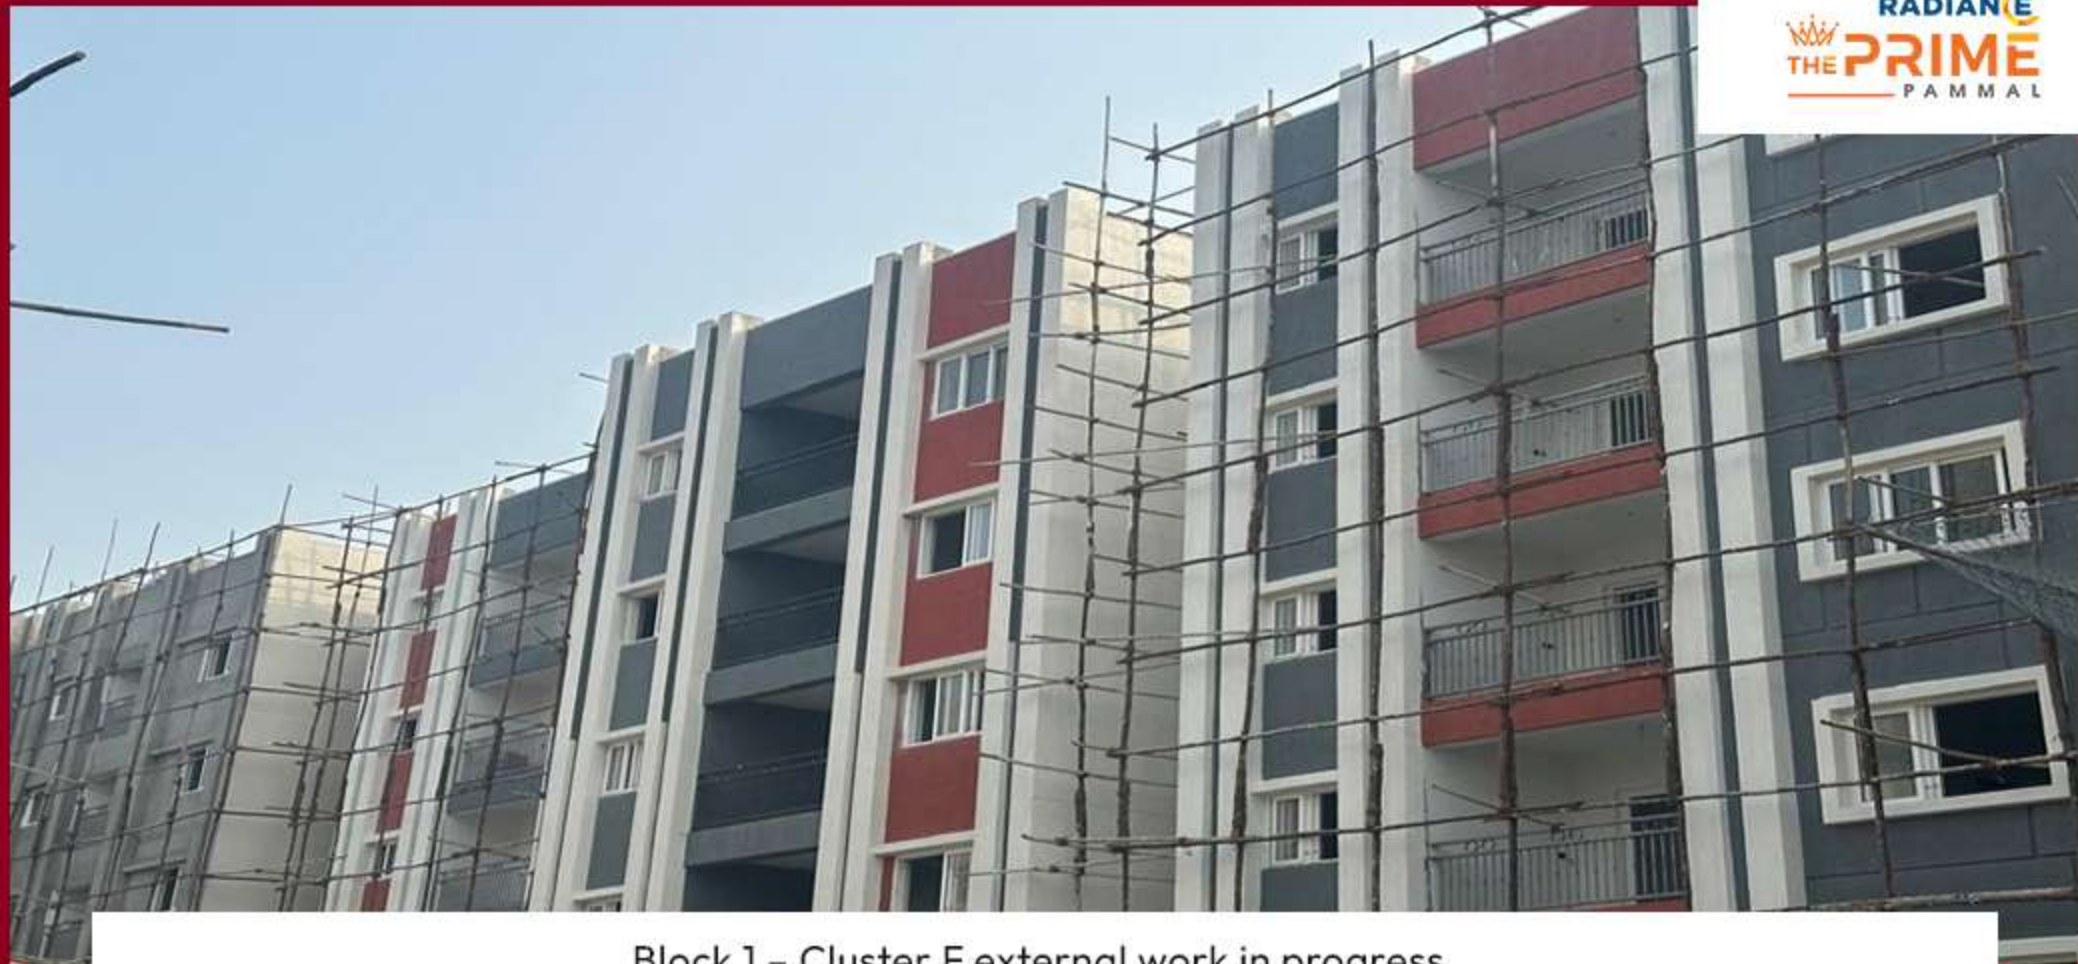
Block 1 – Cluster F external work in progress.

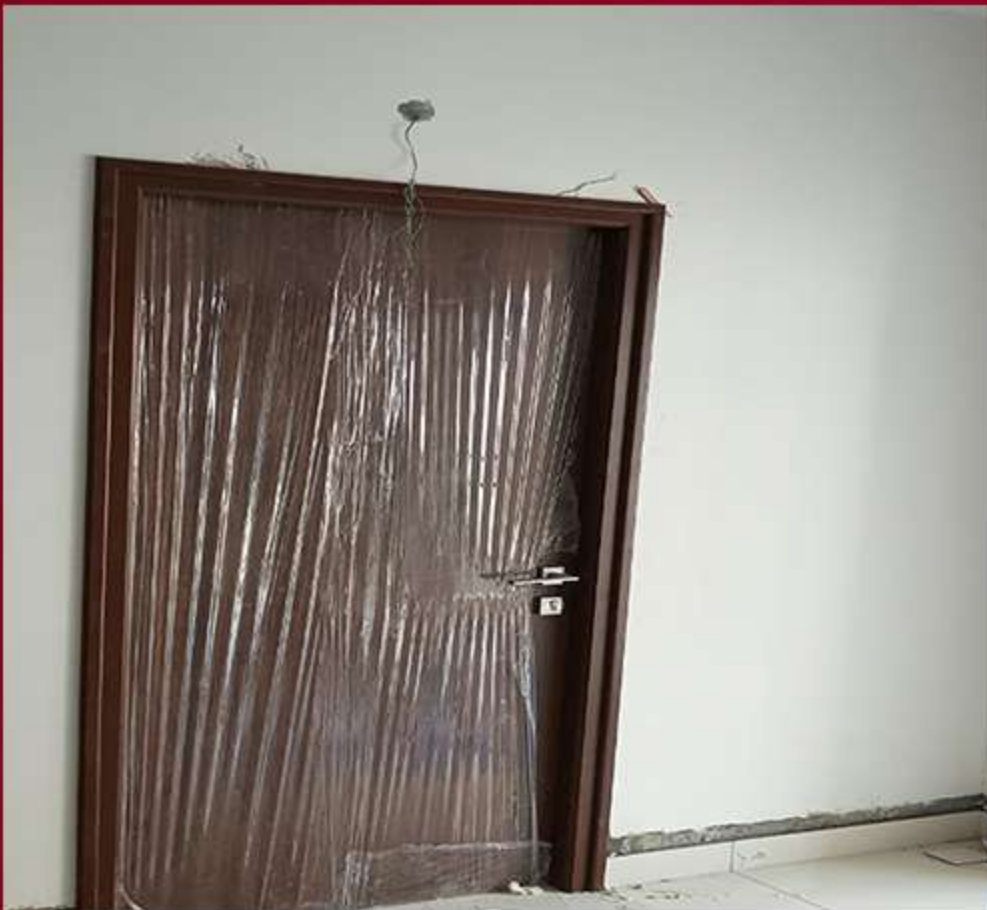
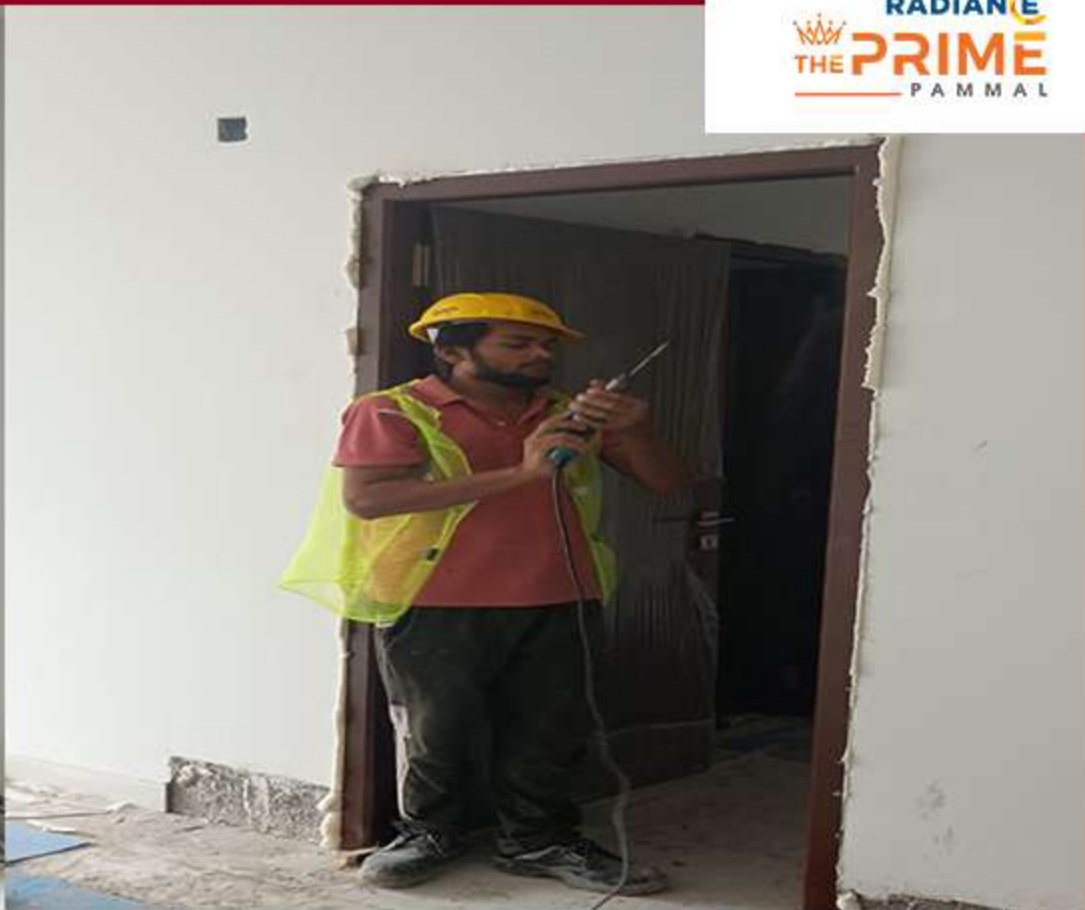
Block 1 – Cluster F doors & frames work in progress.

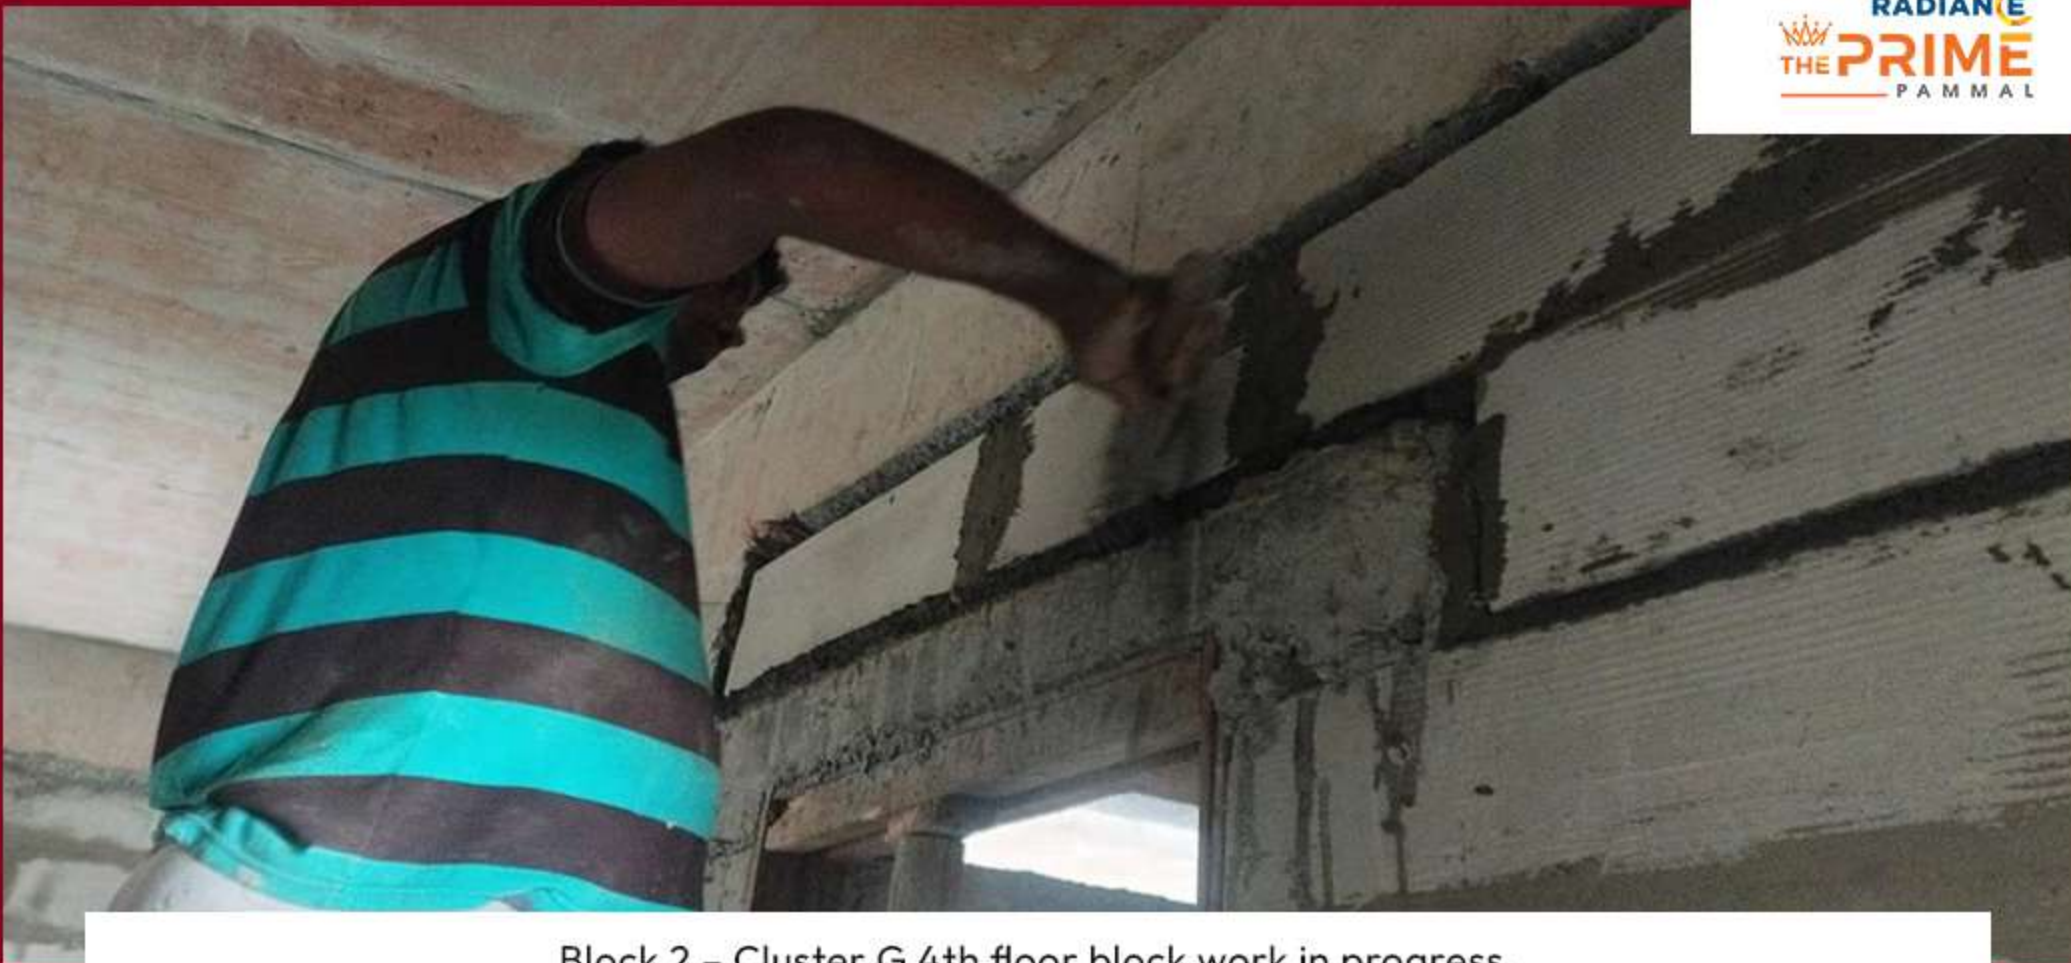
Block 2 – Cluster G 4th floor block work in progress.

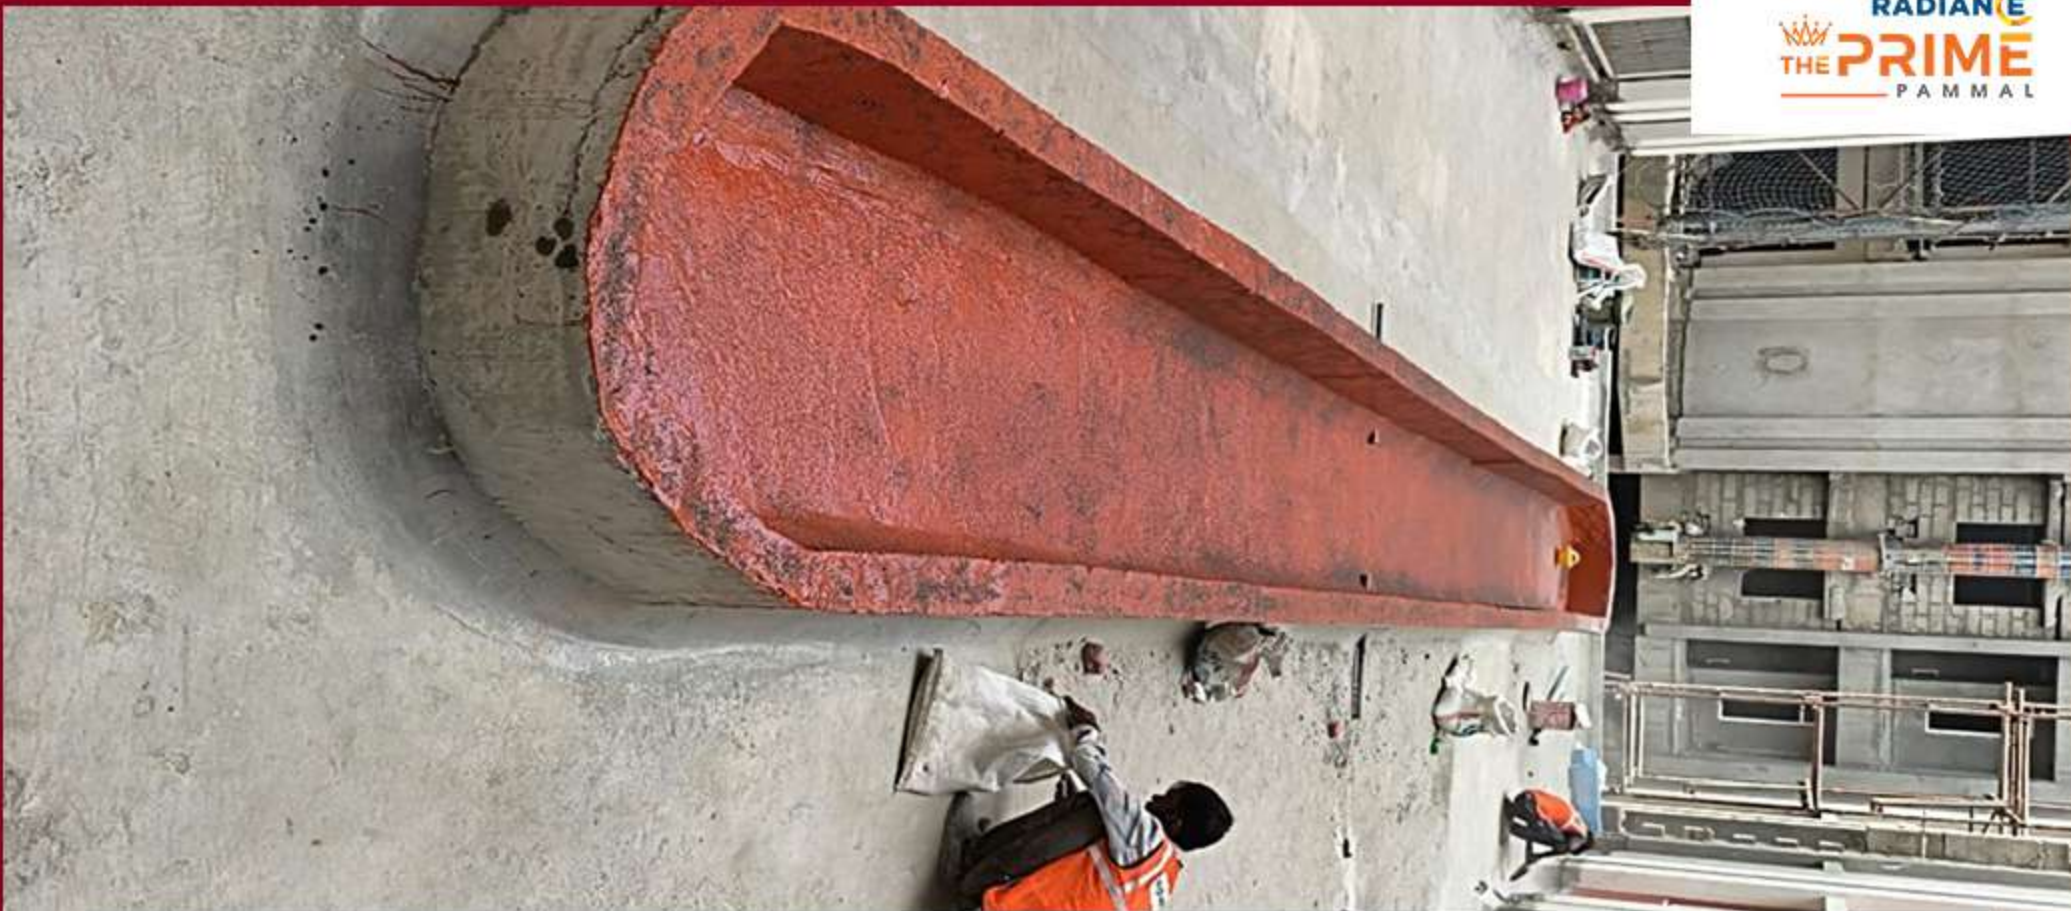
Block 3 – Cluster H & J podium waterproofing work in progress.

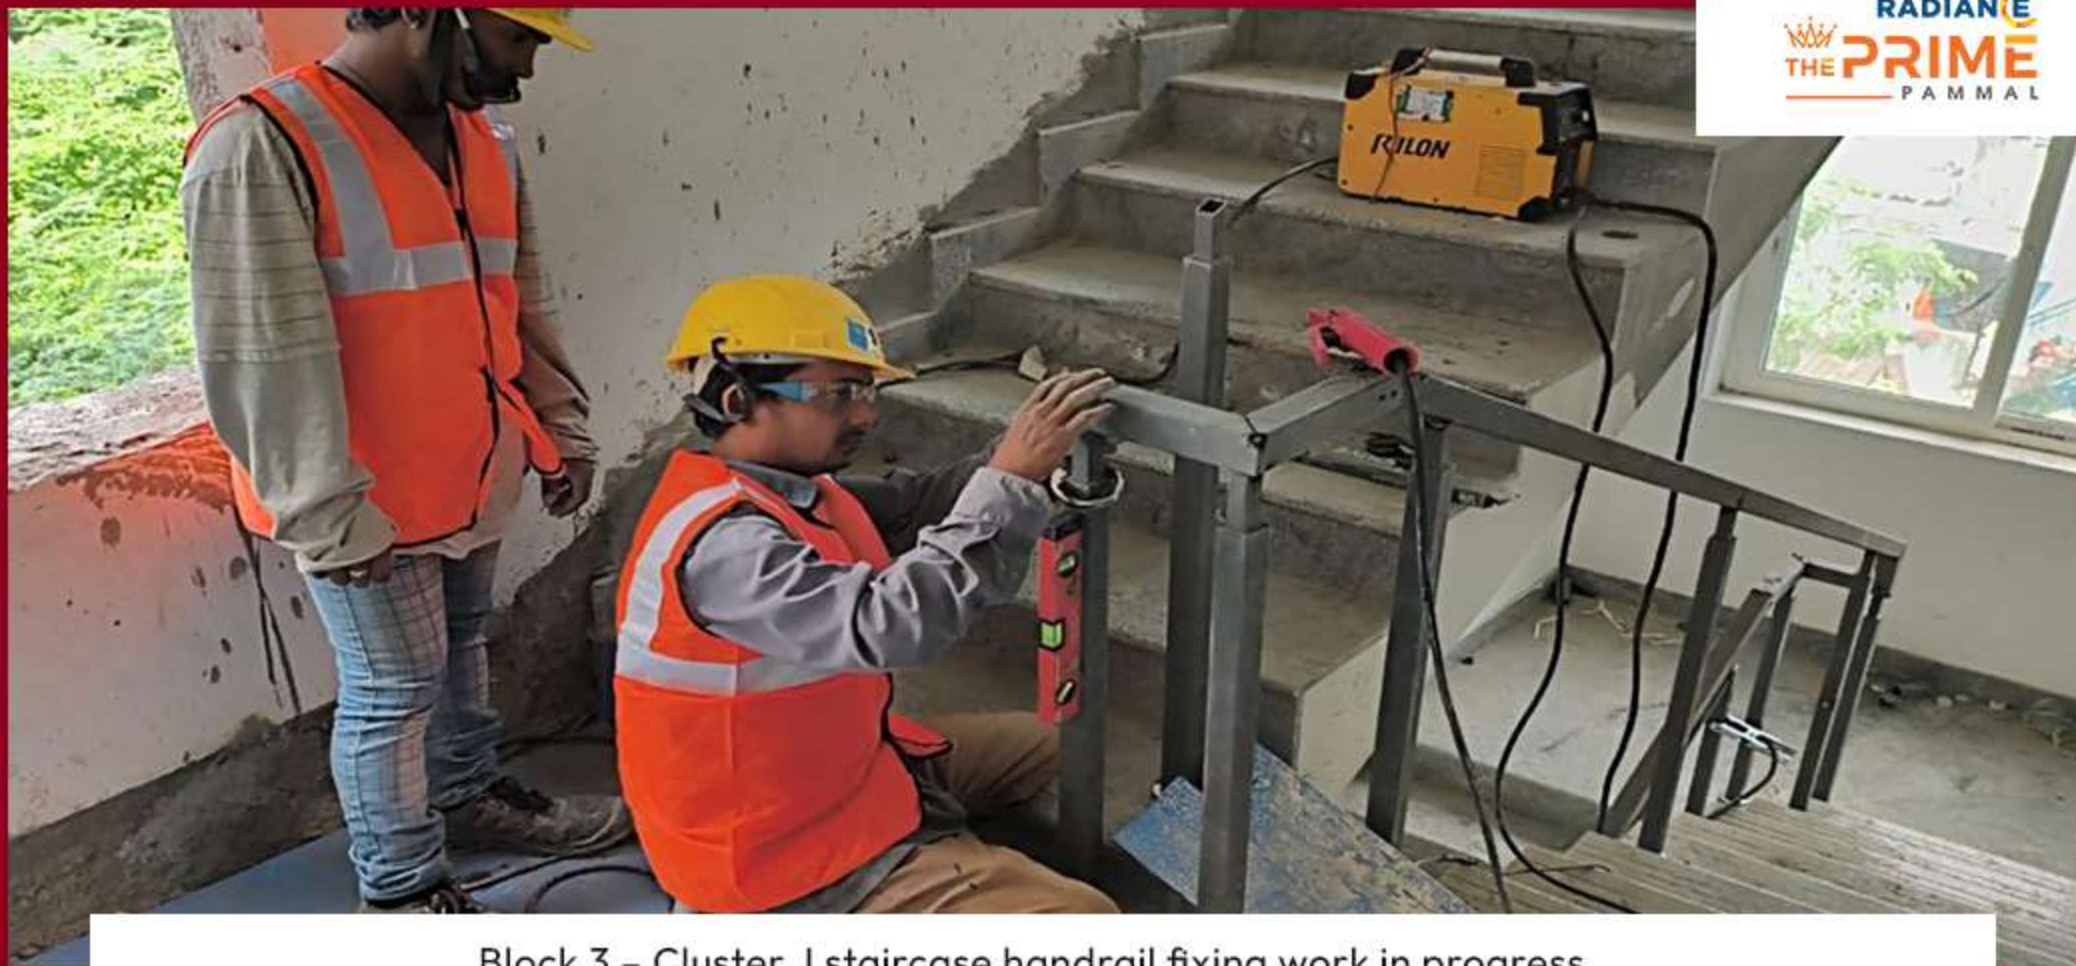
Block 3 – Cluster J staircase handrail fixing work in progress.

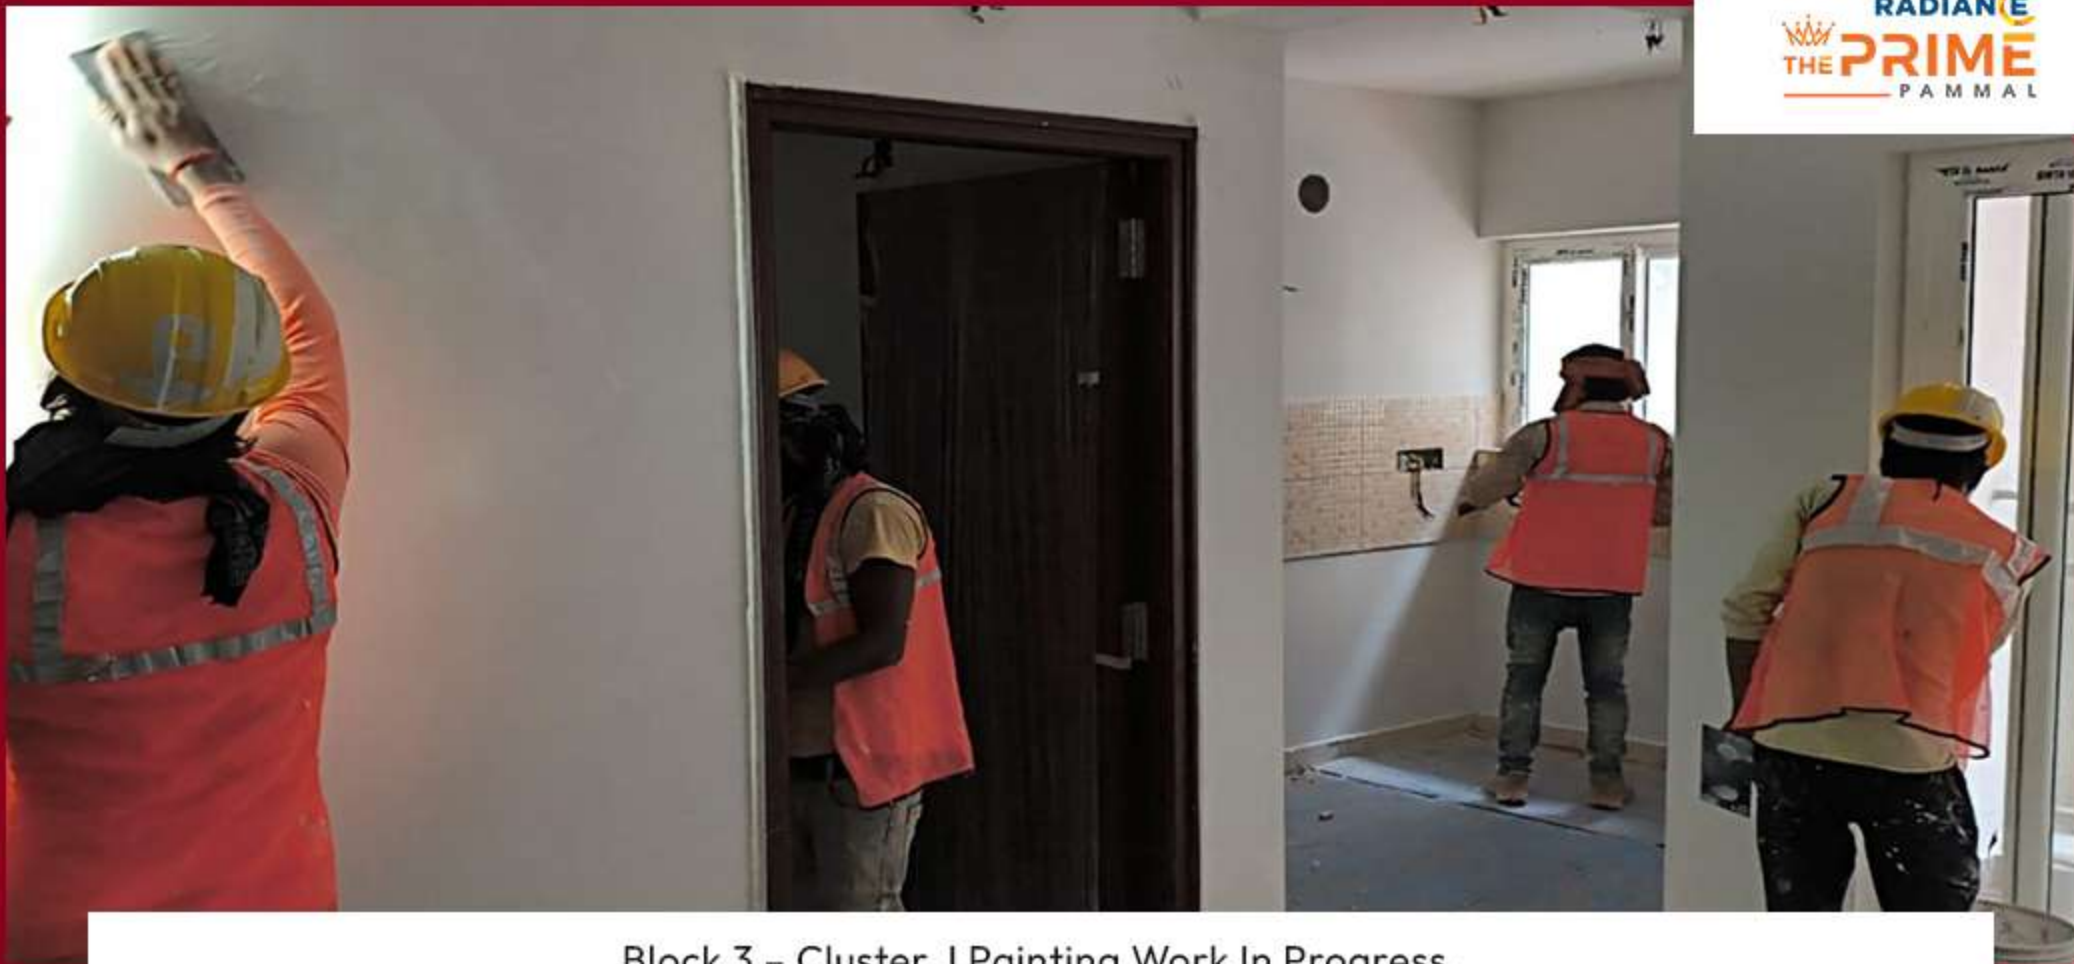
Block 3 – Cluster J Painting Work In Progress.
