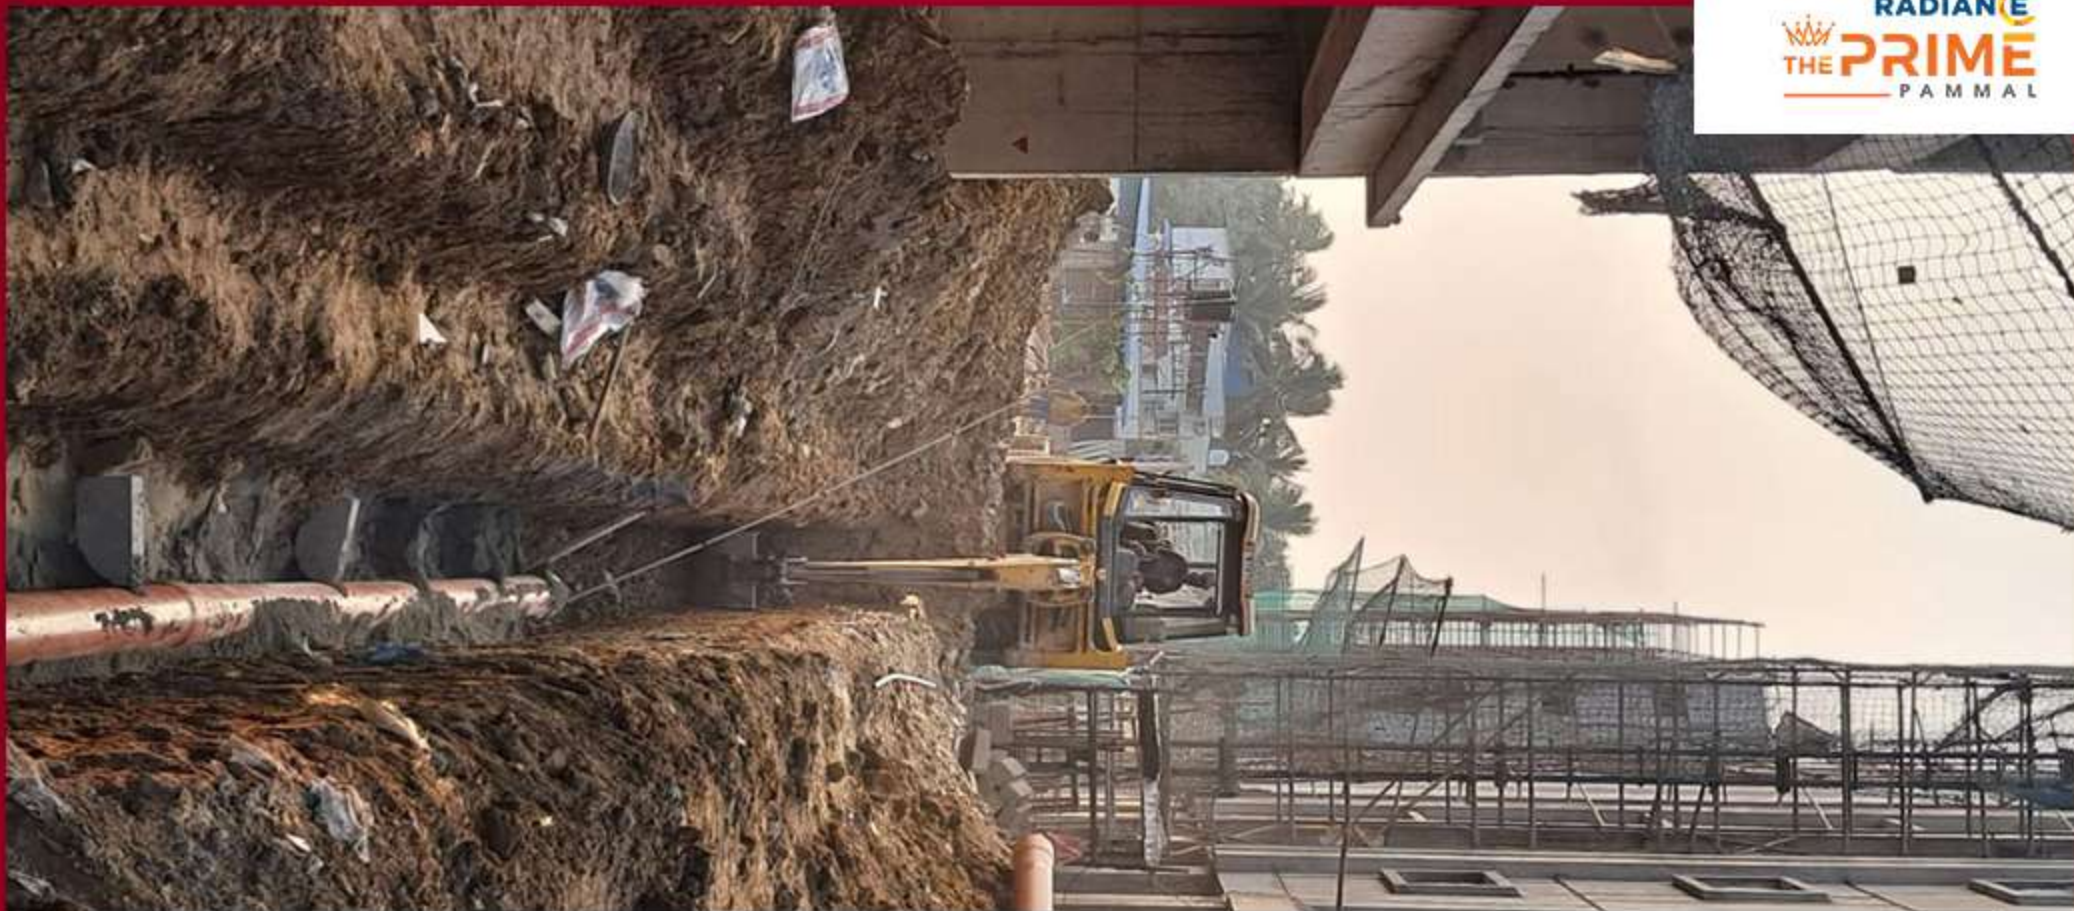
External sewage pipe laying work in progress.
